WSF MUKILTEO TEST PILE PROJECT

**UNDERWATER SOUND LEVELS
ASSOCIATED WITH DRIVING STEEL
AND CONCRETE PILES NEAR THE
MUKILTEO FERRY TERMINAL**

*Prepared by:
Jim Laughlin
Washington State Department of
Transportation
Office of Air Quality and Noise
15700 Dayton Avenue North, P.O. Box
330310
Seattle, WA 98133-9710*

March 2007

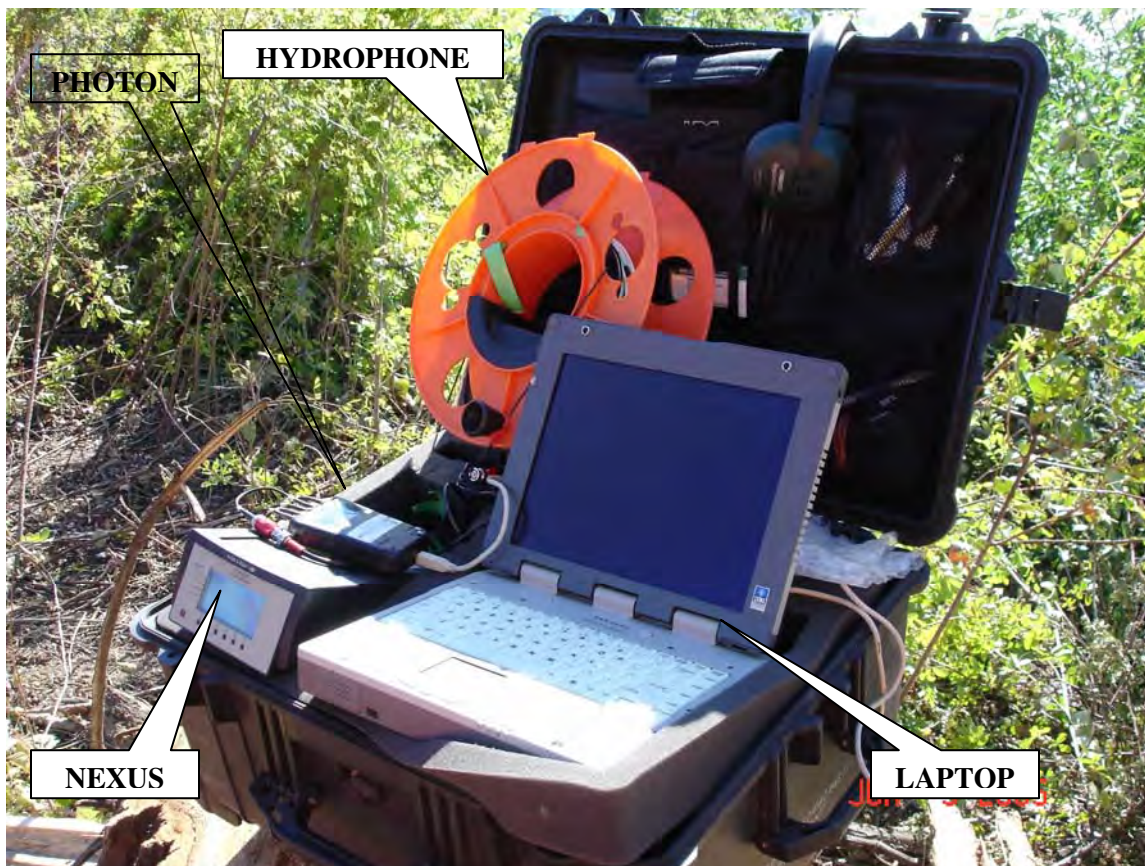
Figure 3: Underwater Sound Level Measurement Equipment

Underwater sound levels were measured using one Reson TC 4013 hydrophone. The hydrophone was positioned at mid-water level. The hydrophone was located at a distance of 10 meters (33 feet) from the pile being monitored. The measurement system includes a Brüel and Kjær Nexus type 2692 4-channel signal conditioner, which kept the high underwater sound levels within the dynamic range of the signal analyzer (Figure 3). The output of the Nexus signal conditioner is received by a Dactron Photon 4-channel signal spectrum analyzer that is attached to an Itronix GoBook II laptop computer.

The operation of the hydrophone was checked daily in the field using a GRAS type 42AC high-level pistonphone with a hydrophone adaptor. The pistonphone signal was 146 dB re: 1 μ Pa. The pistonphone signal levels produced by the pistonphone and measured by the measurement system were within 1 dB and the operation of the system was judged acceptable over the study period. A photograph of the system and its components are shown in Figure 4.

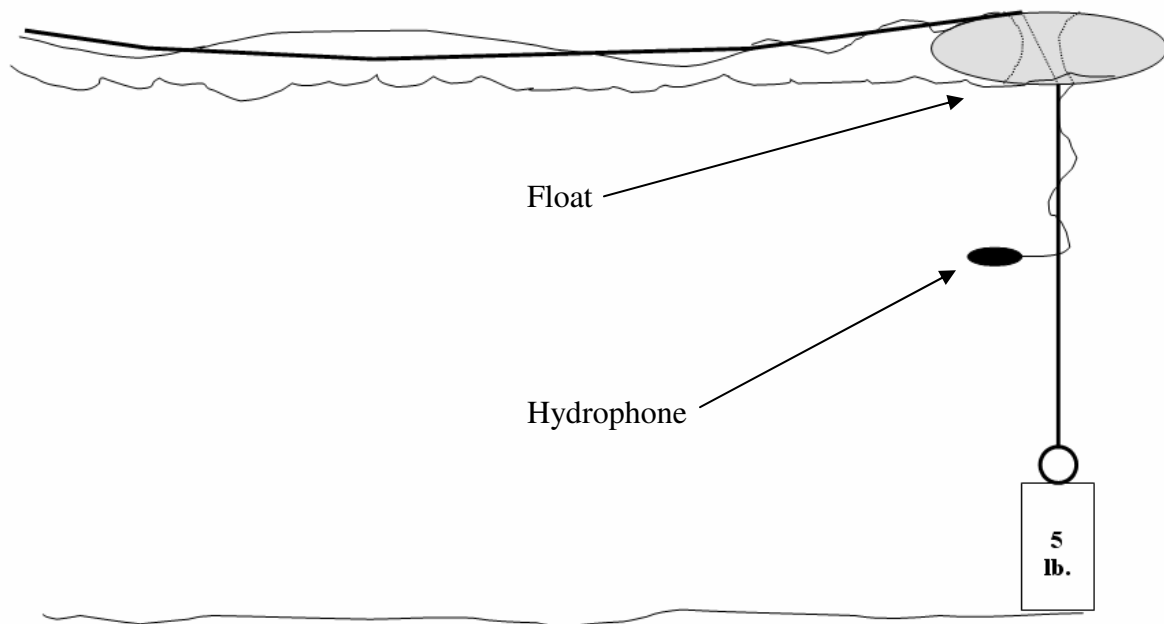
Figure 4: Diagram of hydrophone deployment at the monitoring locations.

The location of the hydrophone is determined by allowing a clear line of sight between the pile and the hydrophone, with no other structures nearby. The distance from the pile to the hydrophone location was measured using a Bushnell Yardage Pro rangefinder. The hydrophone was attached to a weighted nylon cord anchored with a five-pound weight. The cord and hydrophone cables were attached to a surface float at 33 feet (10 meters) from the pile (Figure 4) for monitoring piles.

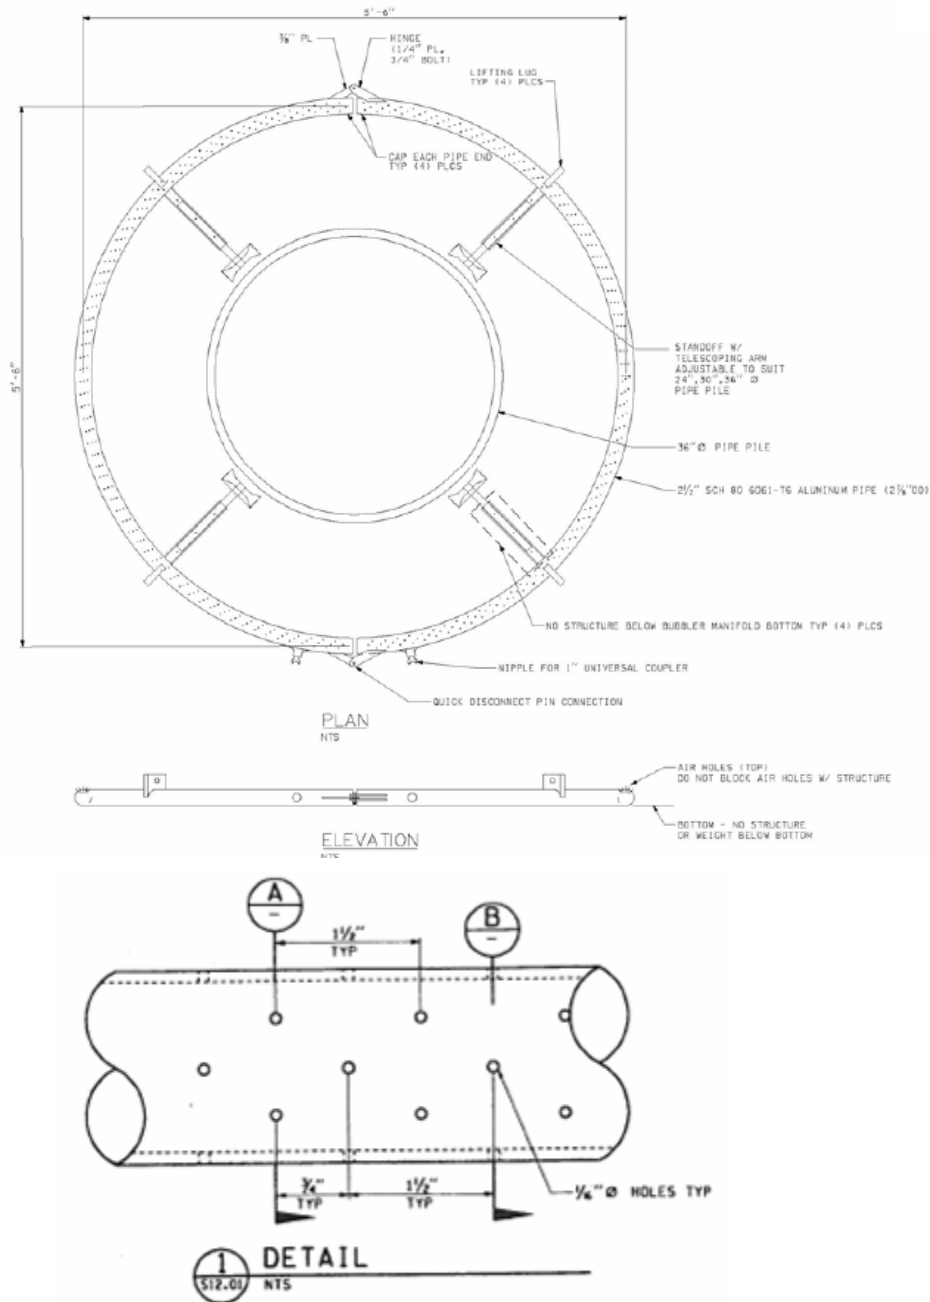
Figure 5: Diagram of the bubble curtain ring system used for this project and the bubble curtain hole spacing pattern.

The final bubble curtain design that was used by the contractor for the Mukilteo Test Pile Project is similar to the bubble curtain used at the Friday Harbor Ferry Terminal Project in 2005 (Figures 5 and 6). The air flow rate through the bubble curtain is 400 cfm at 75 psi. The major difference between these bubble curtains is that the Mukilteo bubble curtain (below) had no projections on the bottom ring to prevent it from seating itself flat on the bottom.

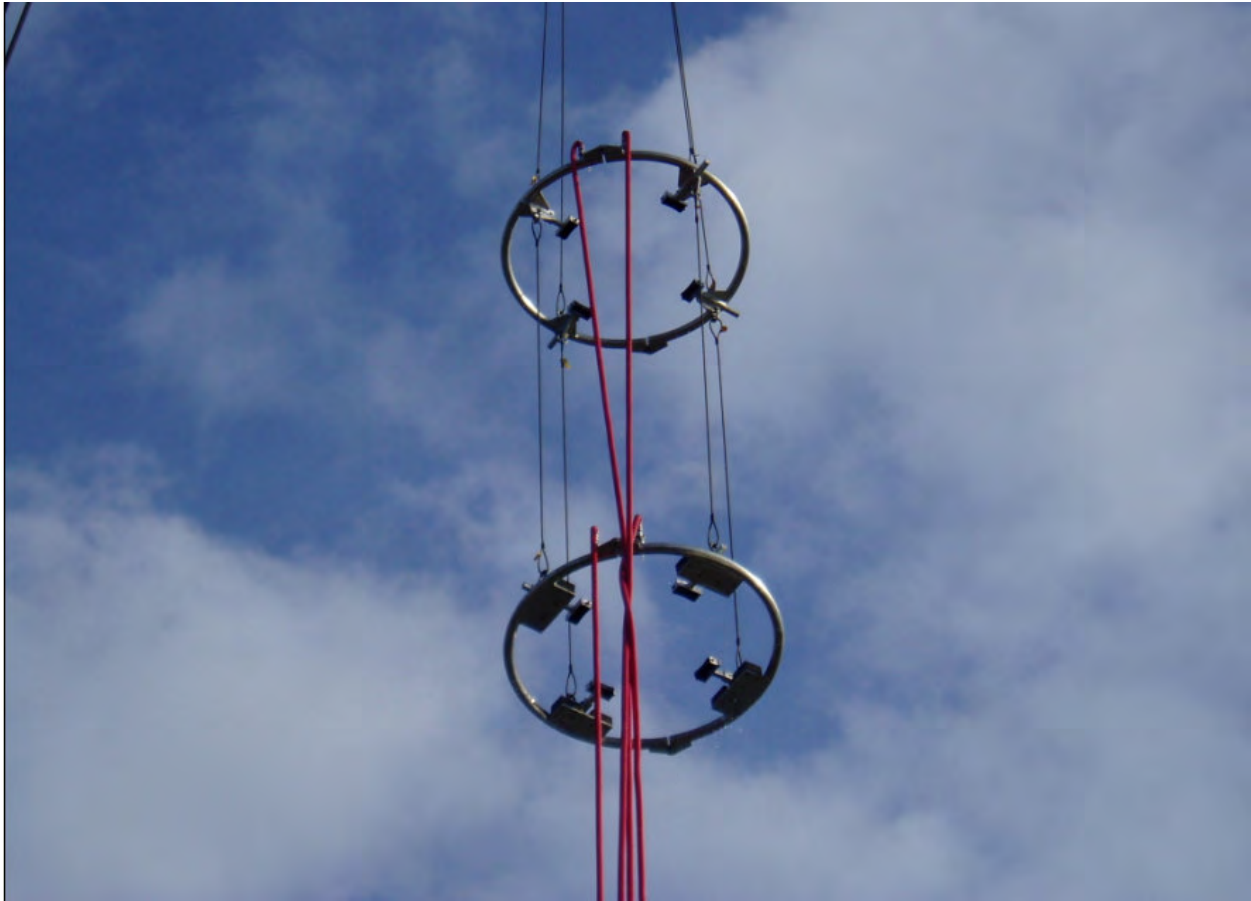
Figure 6: Photograph of the bubble curtain prior to deployment around the pile.

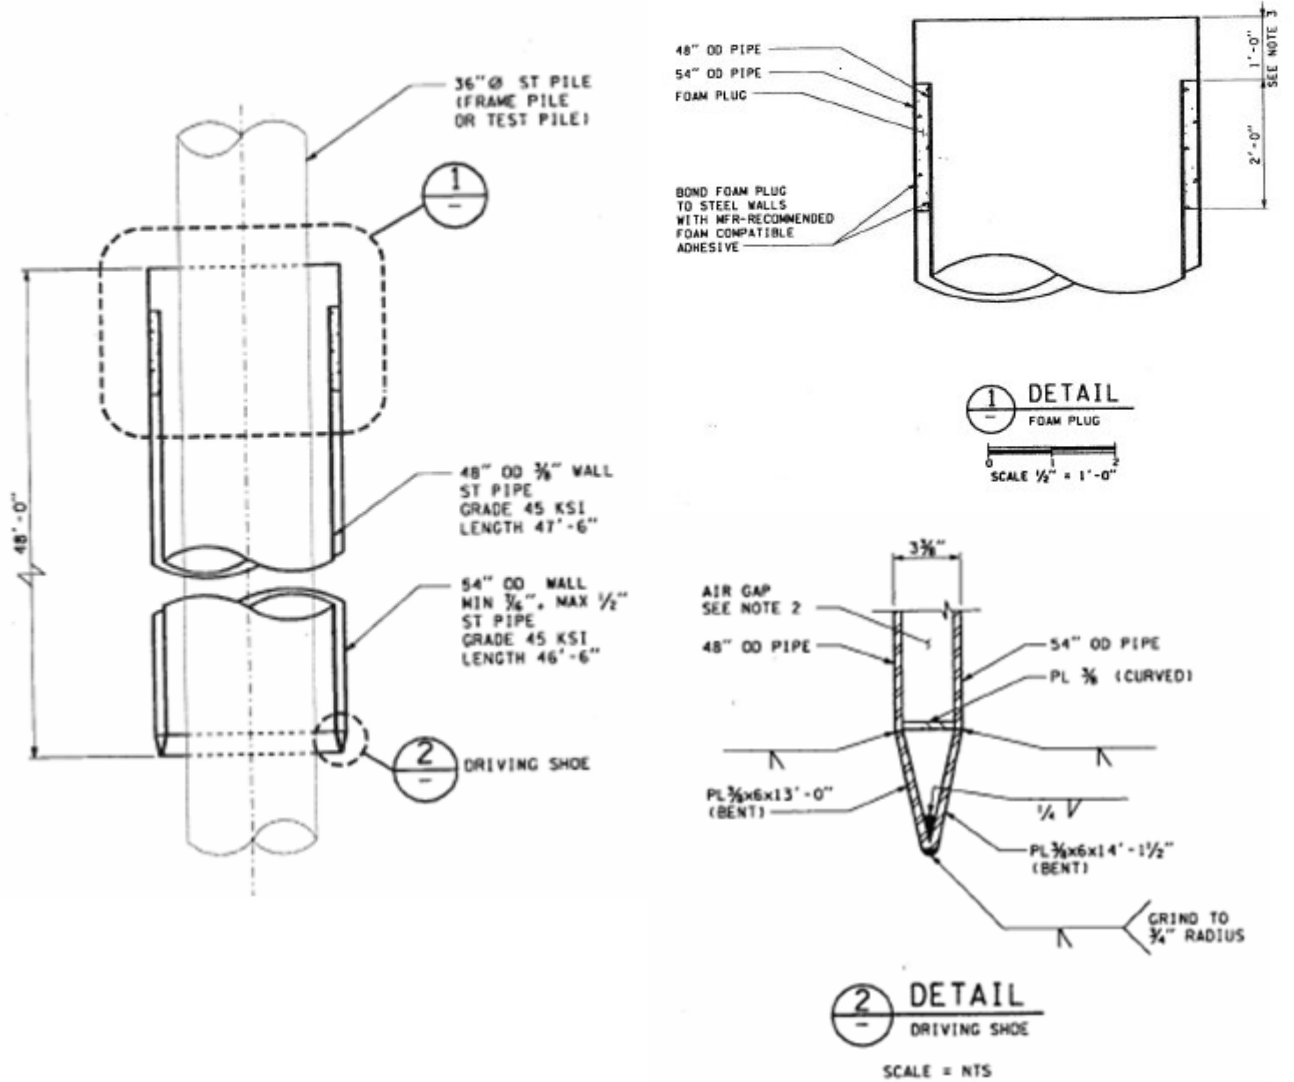
Figure 7: Double Walled TNAP Schematics.

Two new Temporary Noise Attenuation Pile (TNAP) devices were tested as a part of this test pile project. The first TNAP tested (TNAP1) is a hollow steel pile casing with a 2-inch air filled hollow wall (Figures 7 and 8). The TNAP is placed around the pile being driven from the sediment surface to a few feet above the surface waterline. During initial testing of TNAP1 it was determined that it was not providing an effective amount of attenuation. Later it was discovered that the hollow wall had leaked and filled with water making TNAP1 ineffective.

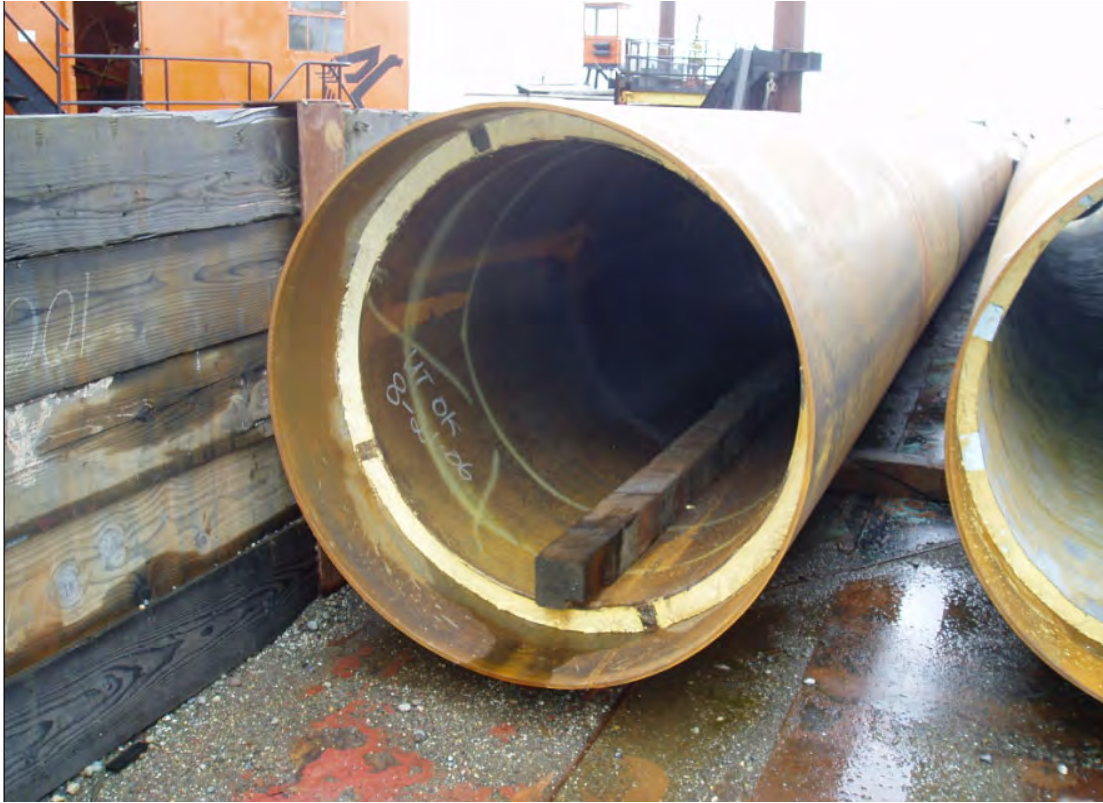
Figure 8: Photograph of the Hollow Walled TNAP on the left.

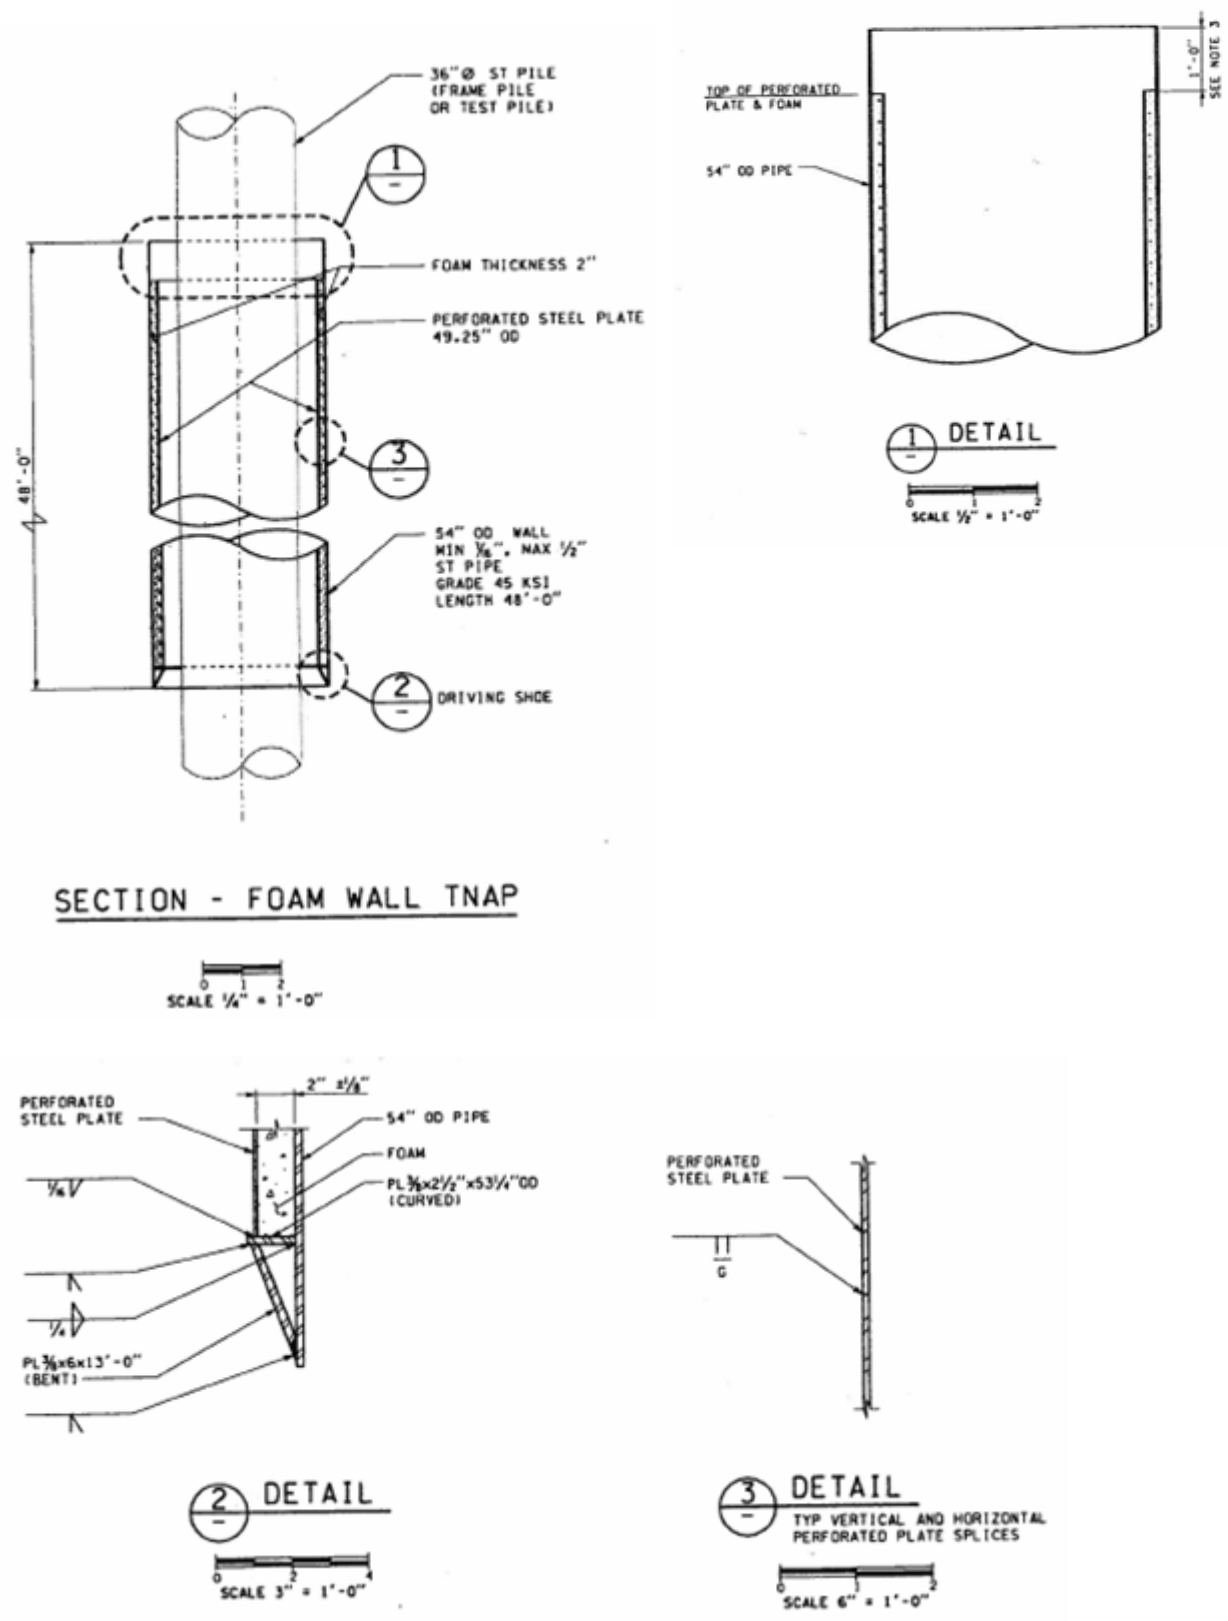
Figure 9: Schematic of the Foam Walled TNAP.

The second TNAP (TNAP2) is a hollow steel pile casing with a 2-inch closed cell foam liner inside the pile (Figures 9 and 10). This TNAP was found to be almost as effective in mitigating sound levels as the bubble curtain for this location.

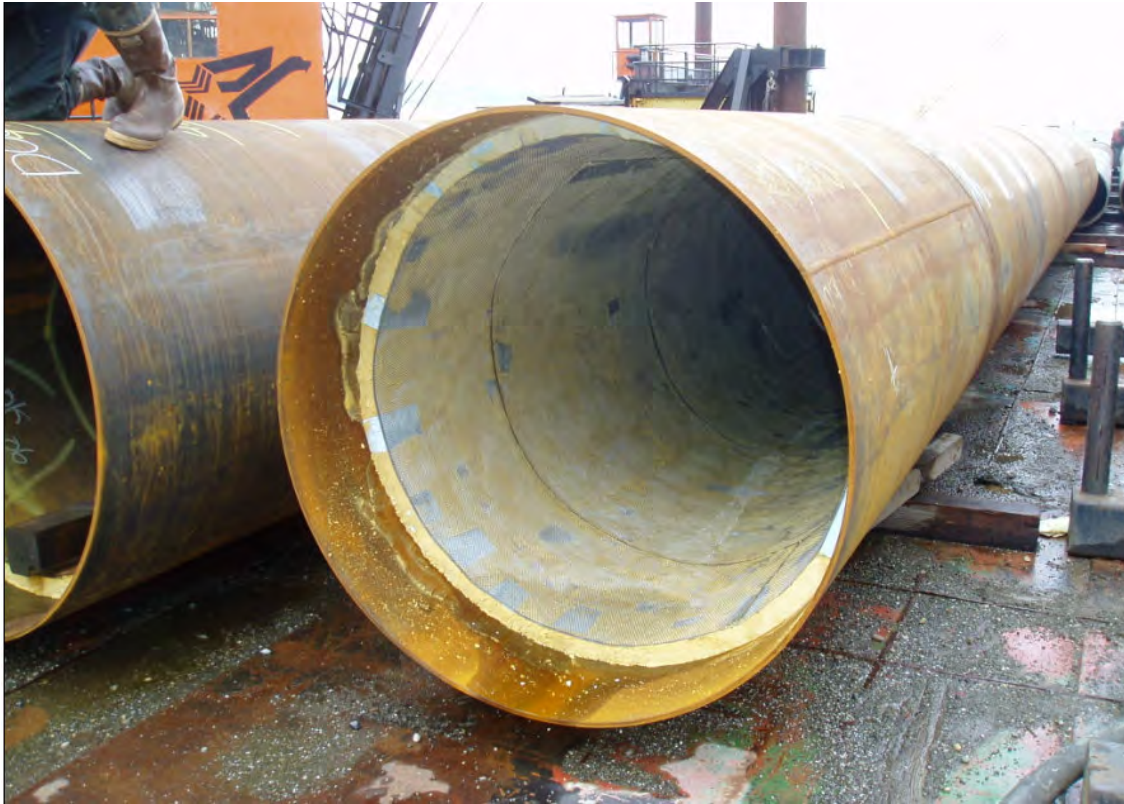
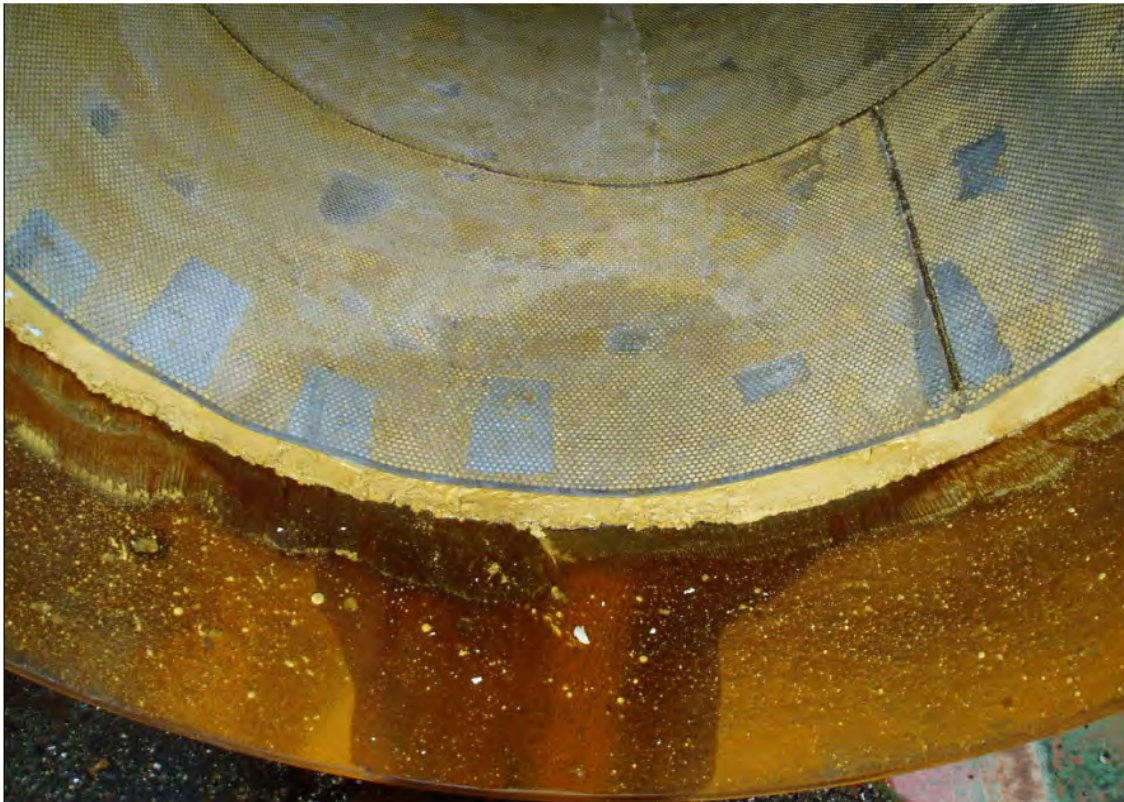
Figure 10: Photograph of the Foam Walled TNAP on the right side in upper photo with a close-up of the foam lining and perforated steel mesh on the inside (bottom photo).

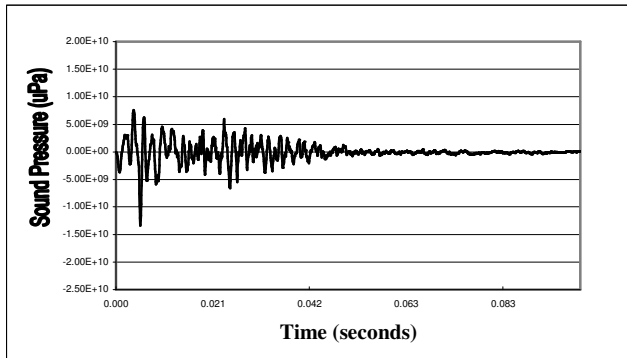
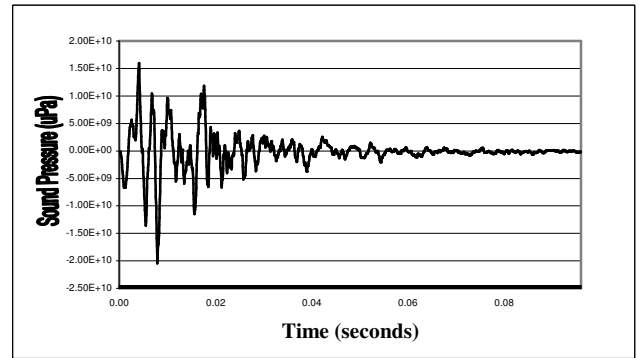
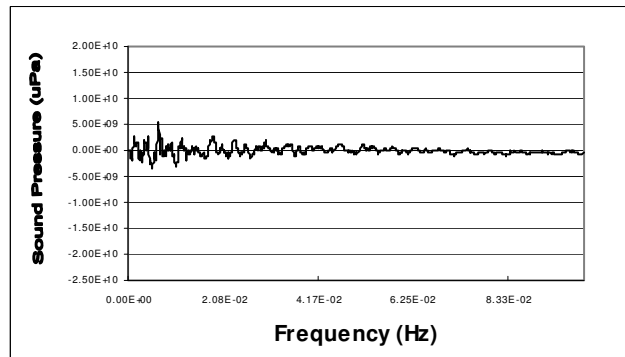
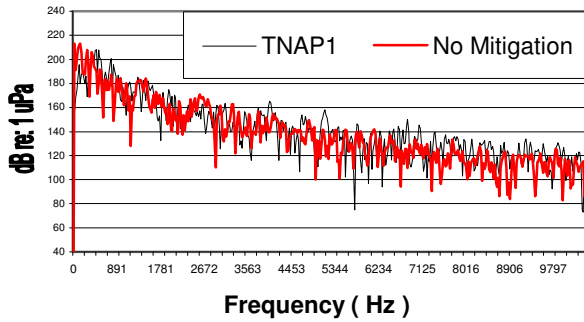
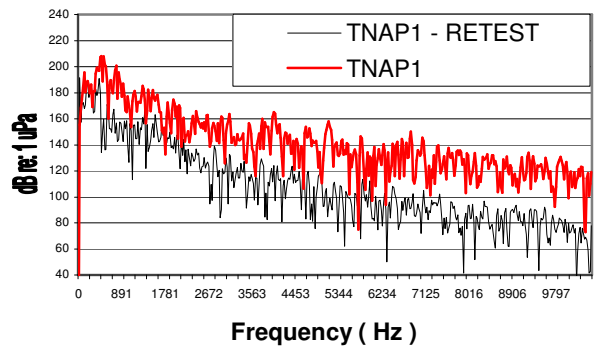
Figure 11: Waveforms and frequency spectral analysis for pile R4 using TNAP1.

On February 19, 2007 the TNAP1 was repaired and was retested on Pile R4. Figure 11c indicates the peak pile strike waveform with the repaired TNAP1. When compared to the ineffective TNAP1 (Figure 11a) it can be seen that there was further reductions in sound levels with the repaired TNAP1.

In Figure 11e the narrow band frequencies of the peak pile strike from the ineffective and repaired TNAP1 are compared. It can be seen that there are further suppression of the higher frequencies which also correlates to the drop in amplitude of the peak pile strike seen in Figure 11c.

Pile R4 was driven with a diesel hammer in a water depth of 24 feet and utilized the hollow walled Temporary Noise Attenuation Pile (TNAP1). Three shiner perch were killed during the initial driving of this pile. Then a bubble curtain was activated on the adjacent pile T2 and no further fish kills were observed. It was discovered after monitoring was completed that the TNAP1 hollow wall had leaked and filled with water rendering it ineffective. The sound levels for Pile R4 in Table 2 indicate that when compared to another similar pile without mitigation there was only a 4 to 9 decibel noise reduction. However, it is uncertain whether this sound reduction was the result of a partially functioning TNAP or the bubbles in the water column.

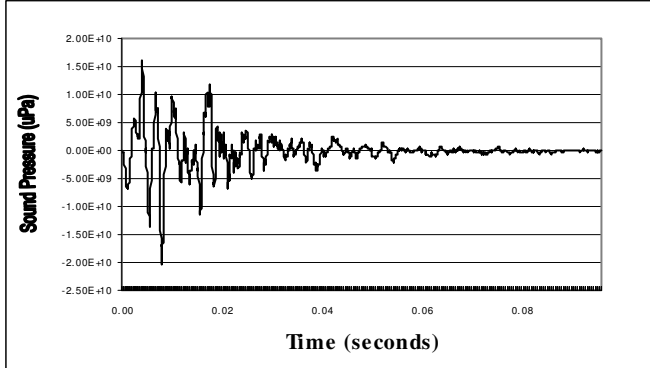
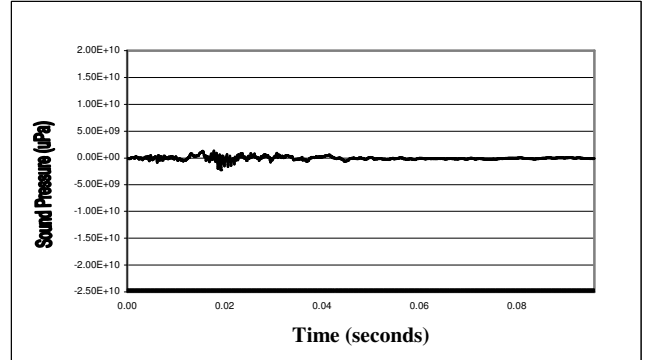
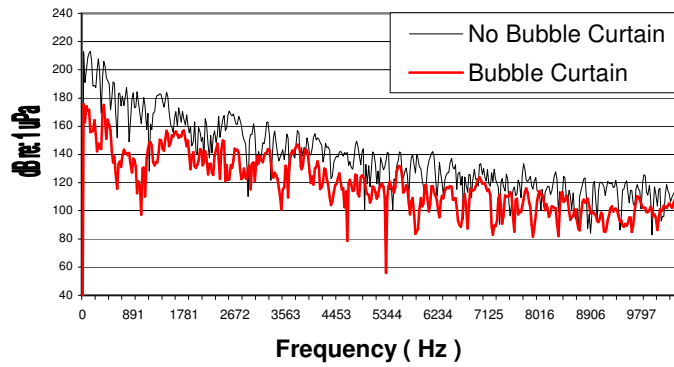
In Figure 12c the narrow band frequencies of the peak pile strikes for the bubbles on and off conditions for Pile R2 are compared. In this spectral analysis there appears to be suppression of both the upper and lower frequencies which also correlates to the drop in amplitude of the peak strike seen in figure 12b and the higher sound reductions associated with the lower frequencies.

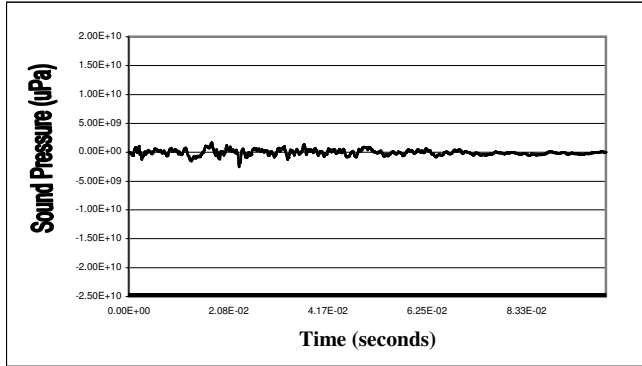
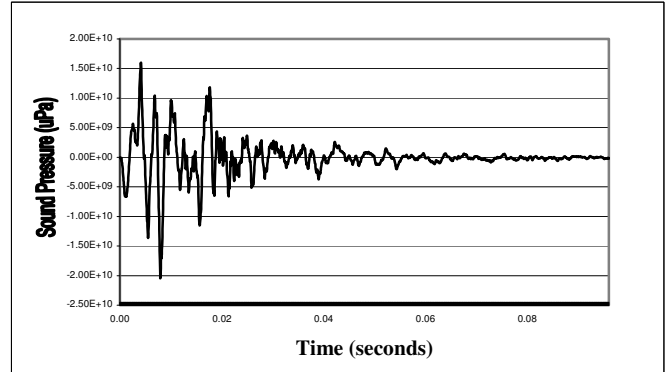
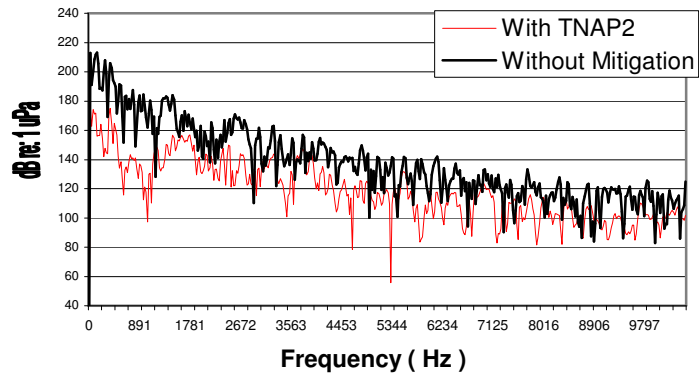
Pile R3 was driven in water depth of 25 feet utilizing the closed cell foam lined TNAP2. For this pile there was a concern about potential fish kills as we had seen using the previous TNAP1 on Pile R4 and because the bubble curtain rings diameter were not large enough to fit around the TNAP2 to serve as a backup mitigation device. Therefore, it was decided that the bubble curtain would be placed on pile R2 near pile R3 and turned on for approximately 2 minutes prior to driving the pile in an attempt to scare the fish away. The bubble curtain was turned off and pile driving was started.

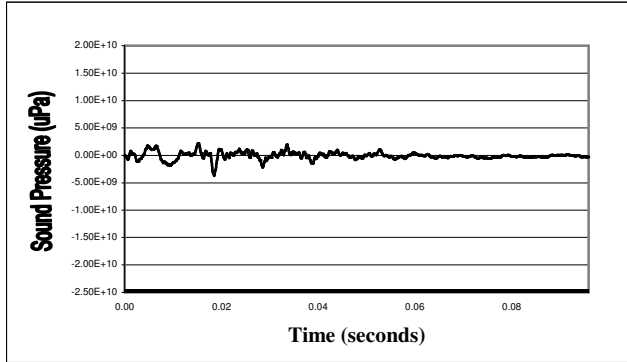
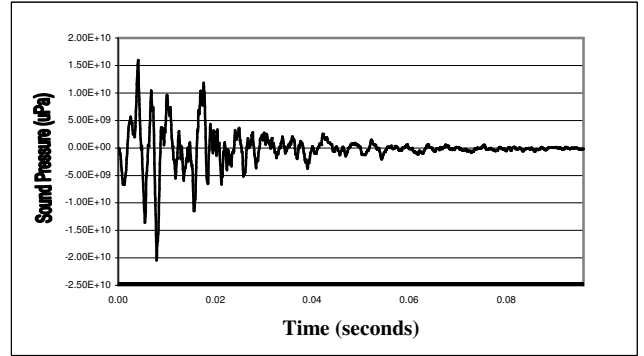
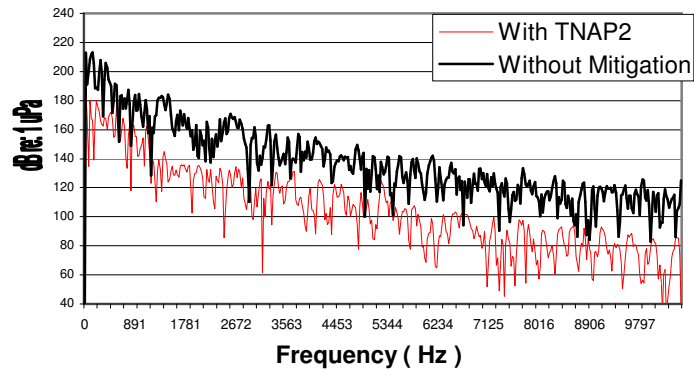
Pile R1 was driven in water depth of 26 feet and relatively firm sediments with the TNAP2 in place. To further test the effectiveness of TNAP2 it was decided to utilize TNAP2 on pile R1 so that we could get replicate results.

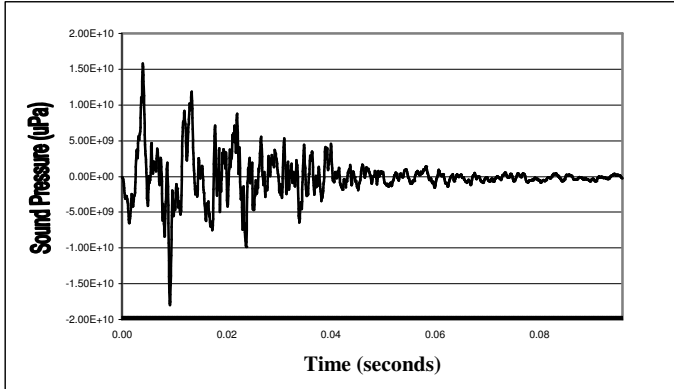
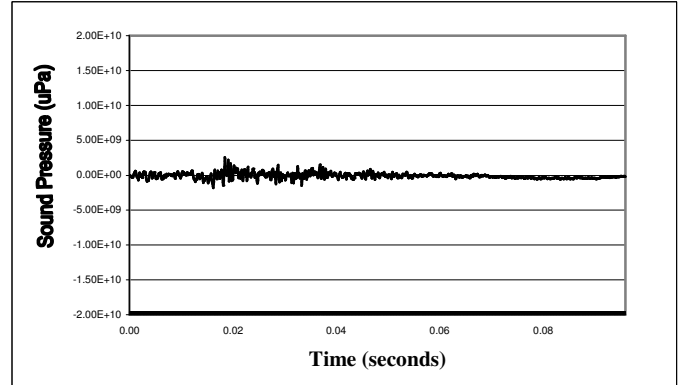
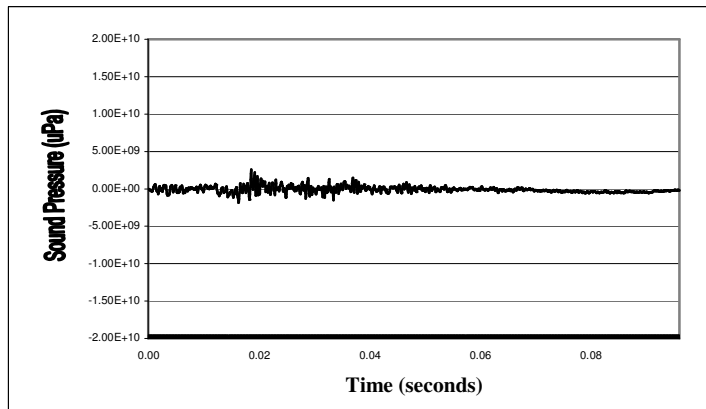
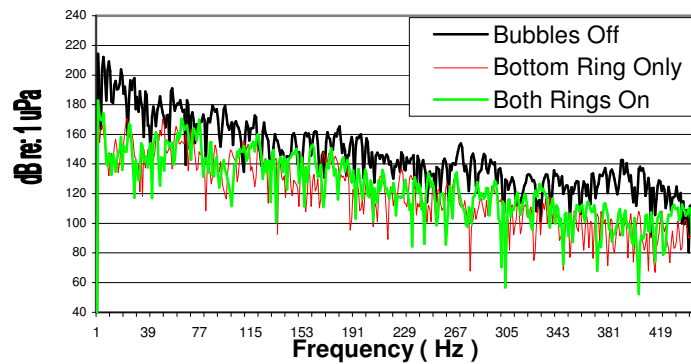
Figure 15a indicates the peak strike waveform with no bubble curtain. Figure 15b indicates the peak strike waveform with the air to only the bottom ring of the bubble curtain turned on. Figure 15c indicates the waveform with the air to both bottom and middle rings turned on. There is very little difference between the waveforms in 15b and 15c indicating that the addition of the second ring 10 feet above the bottom did very little to increase the noise reductions. These results are similar to what was observed for bubble curtain testing at the Friday Harbor pile driving monitoring in 2005 (Laughlin, 2005). The Friday Harbor results indicate that adding air from additional bubble curtain rings does not significantly increase sound reductions.

Pile T2 was driven in water depth of 27 feet in relatively soft sediments with a bubble curtain operating. The bubble curtain utilized two separate rings, one on the bottom and one 10 feet above the bottom. The air was turned on for the bottom ring only first then air to both rings was turned on. Then bubbles were turned off for approximately the last two minutes.

Table 4 also provides additional support that adding the second bubble ring 10 feet above the bottom does not increase benefit in noise reductions. Table 4 indicates the highest absolute peak recorded for this pile was 214 dB_{peak} with the bubbles off and 188 dB_{peak} for both the bottom ring only and both rings on conditions. The highest RMS is 201 dB_{RMS} for the bubbles off condition, 172 dB_{RMS} for the bottom ring only condition, and 171 dB_{RMS} for both rings on condition. The highest SEL for the peak strike is 184 dB_{SEL} with no bubbles on, 162 dB_{SEL} with only the bottom ring bubbles on, and 161 dB_{SEL} with both bubble rings on. 97% of the strikes exceeded 180 dB_{peak} with the bubble curtain off and 95% exceeded 180 dB_{peak} with both the bottom ring and both rings on conditions. All the strikes exceeded 150 dB_{RMS}. The average peak sound reductions achieved with the bubble curtain was 22 dB with both the bottom ring only and both rings on.

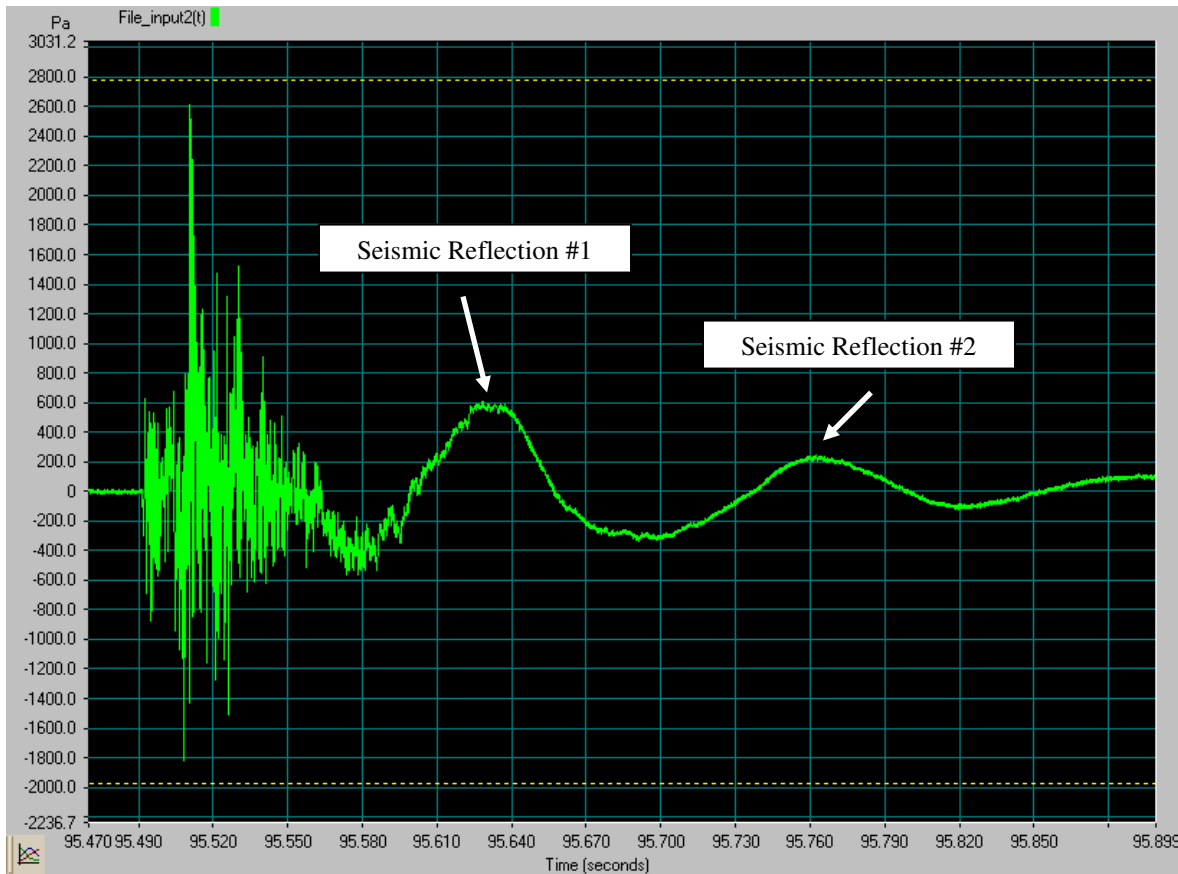
Another interesting observation was that for all of the steel piles there was a series of two and sometimes three Scholte waves or seismic reflections that occurred after the main pile strike (see Figure 16). This was observed on all pile strikes and they are generated at the water sediment interface. The first reflection occurred 0.1174 seconds after the initial strike and had a peak value of 176 dB_{peak}. This is likely site specific and a result of the softer sediment conditions at this location.

Figure 16: Pile T2 Pile Strike Indicating Seismic Reflections.

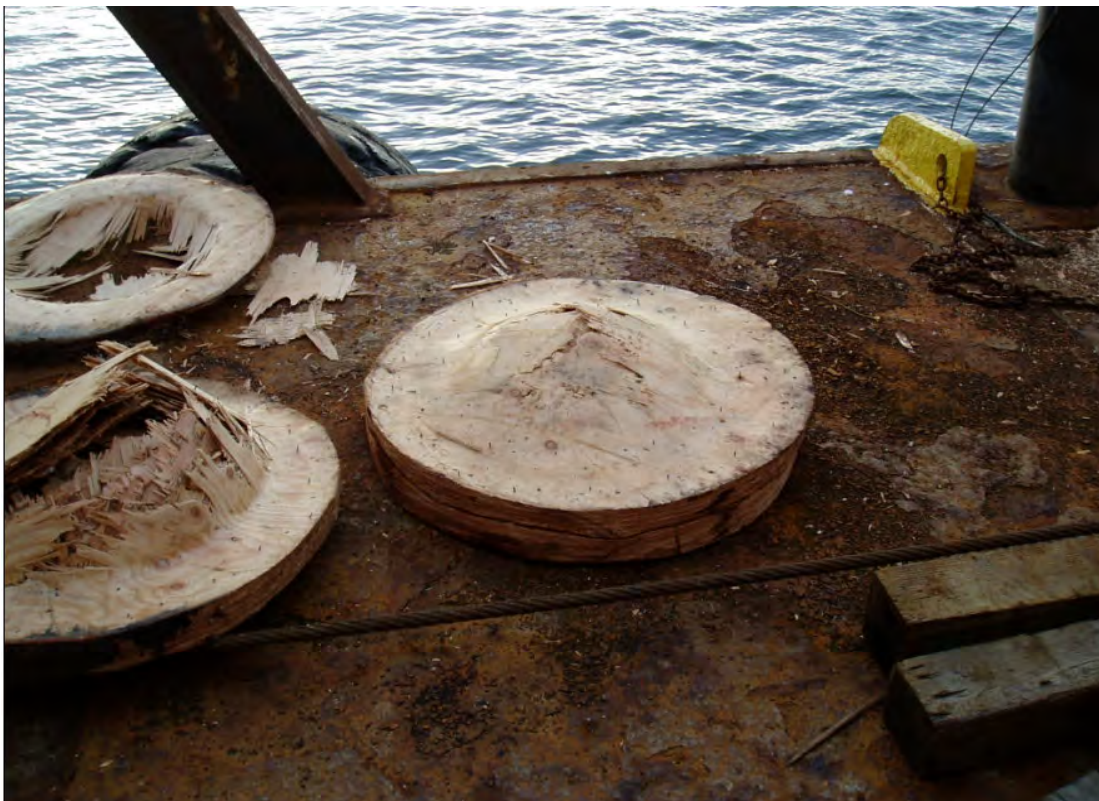
Figure 17: Photograph of one of four previously used 4-inch thick plywood stacked disks that formed the wood pile cap for the concrete piles.

Figure 18a indicates the peak strike waveform for the octagonal concrete pile. For comparative purposes Figure 18b indicates the peak strike waveform for a steel pile (T2) with no noise attenuation device. When these two figures are compared against each other it is apparent that the concrete pile generates much less sound energy into the water than the steel pile. Whether this is due to the wood pile cap, the concrete pile itself, or a combination of the two is not clearly understood. However, it is common practice for all concrete piles to utilize a wood cap.

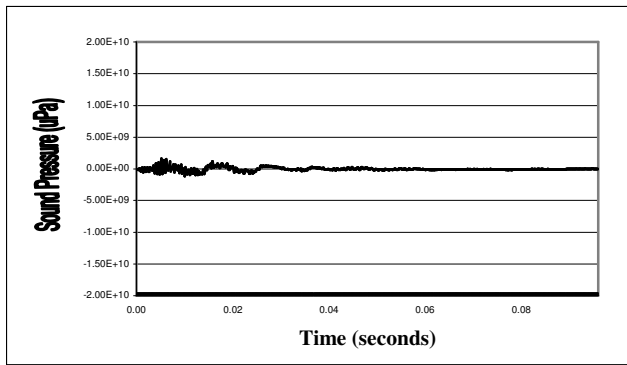
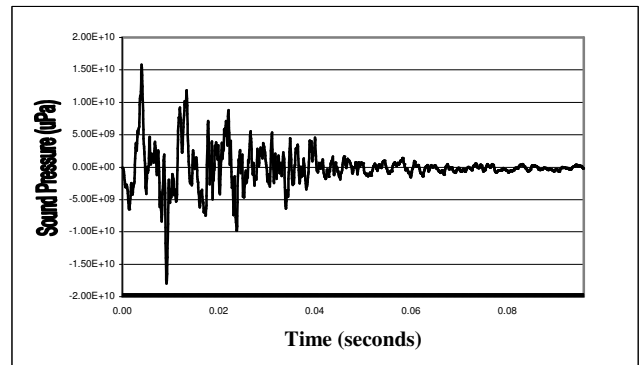
In Figure 12c, the narrow band frequencies of the peak pile strikes for the concrete pile and the steel pile (T2) without mitigation are compared. In this spectral analysis there appears to be suppression of both the upper and lower frequencies in the concrete pile which also correlates to the drop in amplitude of the peak strike seen in figure 12a and the higher sound reductions associated with the lower frequencies.

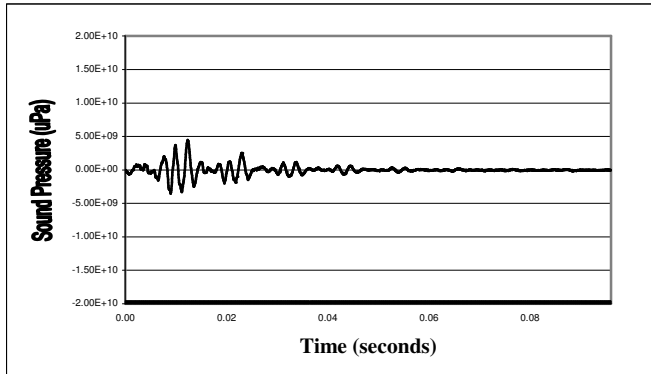
a. Pile T3 (concrete pile)

Figure 19a indicates the peak strike waveform for the hollow concrete pile. For comparative purposes Figure 19b indicates the peak strike waveform for a steel pile (T2) with no mitigation. When compared the hollow concrete pile in Figure 19a is compared to the steel pile in Figure 19b the amplitude is much less than the steel pile.

Figure 19: Waveforms and frequency spectral analysis for pile T3, a hollow concrete pile with a 12-inch wood cap.

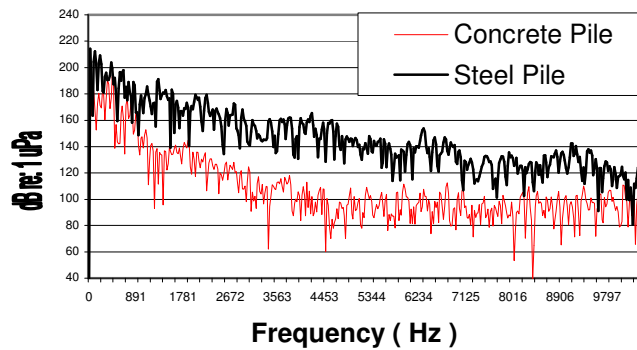
c. Pile T1 Frequency Data Compared to Steel Pile (T2)

In Figure 19c the narrow band frequencies of the peak pile strikes for the concrete pile and the steel pile (T2) without mitigation are compared. In this spectral analysis there appears to be a substantial suppression of both the upper and lower frequencies in the hollow concrete pile which also correlates to the drop in amplitude of the peak strike seen in figure 19a and the higher sound reductions associated with the lower frequencies. Figure 19d the narrow band frequencies of the solid octagonal concrete pile are compared with the hollow concrete pile. As Figure 19d indicates there is very little difference in frequencies of the two piles except Since the 12-inch wood pile cap was used for both the octagonal and hollow concrete piles it is assumed that the reduction of higher frequencies is attributed to the pile cap.

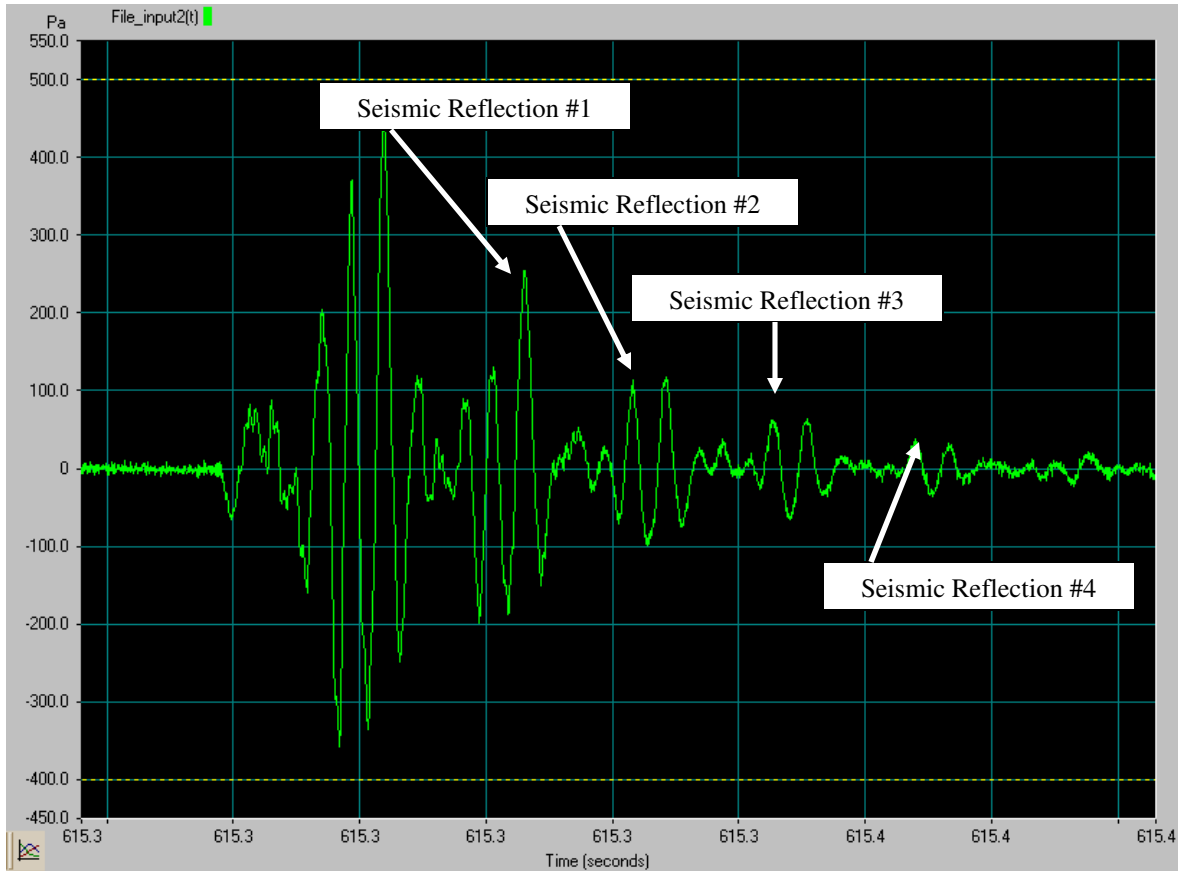
An interesting observation for the concrete piles was that Scholte waves were also seen for each strike. These are seen in Figure 20 as a series of four and sometimes five possible seismic

reflections that occurred after the main pile strike. This was observed on all concrete pile strikes and is unclear what caused this unusual waveform.

Figure 20 Waveforms and frequency spectral analysis for pile T3, a hollow concrete pile with a 12-inch wood cap.

Pile T3 was a 36-inch diameter hollow concrete pile with a 6-inch thick wall driven in a water depth of 25 feet in relatively firm sediments without noise attenuation. The diesel pile driving hammer included a 12-inch thick plywood pile cap between the steel hammer and the concrete pile. Due to the failure of the signal conditioner for this pile this data has been corrected with a scaling factor of 10. While we feel that the data is reasonable it should still be considered to be not completely accurate.

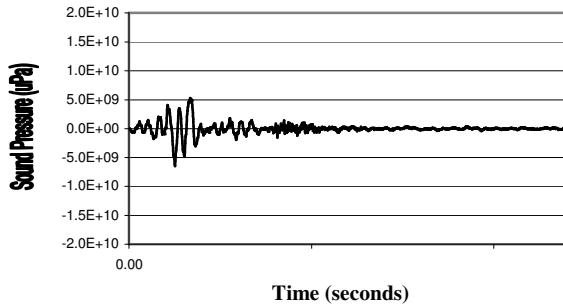
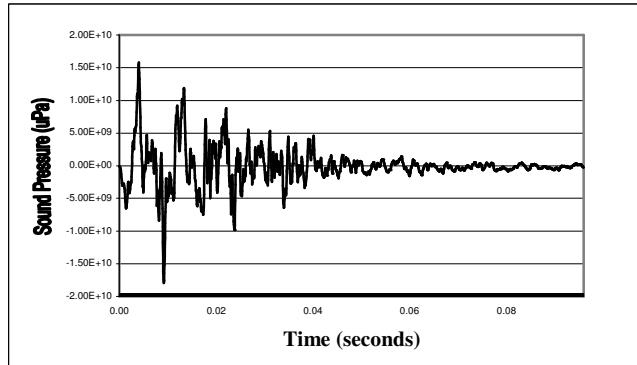
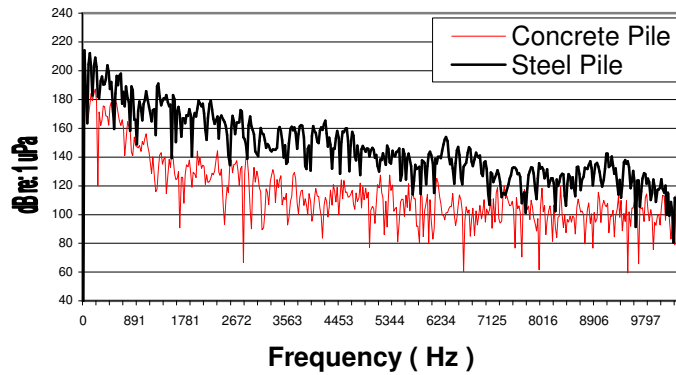
c. Comparison of Hollow Concrete Pile T4 Frequency Data with Steel Pile (T2) Without Mitigation.

Pile T4 was a 36-inch diameter hollow concrete pile with a 6-inch thick wall driven in a water depth of 28 feet in relatively firm sediments without noise attenuation. The diesel pile driving hammer included a 12-inch thick plywood pile cap between the steel hammer and the concrete pile. Due to the failure of the signal conditioner for this pile this data has been corrected with a scaling factor of 10. While we feel that the data is reasonable it should still be considered to be not completely accurate.
