WSF MUKILTEO TEST PILE PROJECT

**UNDERWATER SOUND LEVELS
ASSOCIATED WITH DRIVING STEEL
AND CONCRETE PILES NEAR THE
MUKILTEO FERRY TERMINAL**

*Prepared by:
Jim Laughlin
Washington State Department of
Transportation
Office of Air Quality and Noise
15700 Dayton Avenue North, P.O. Box
330310
Seattle, WA 98133-9710*

March 2007

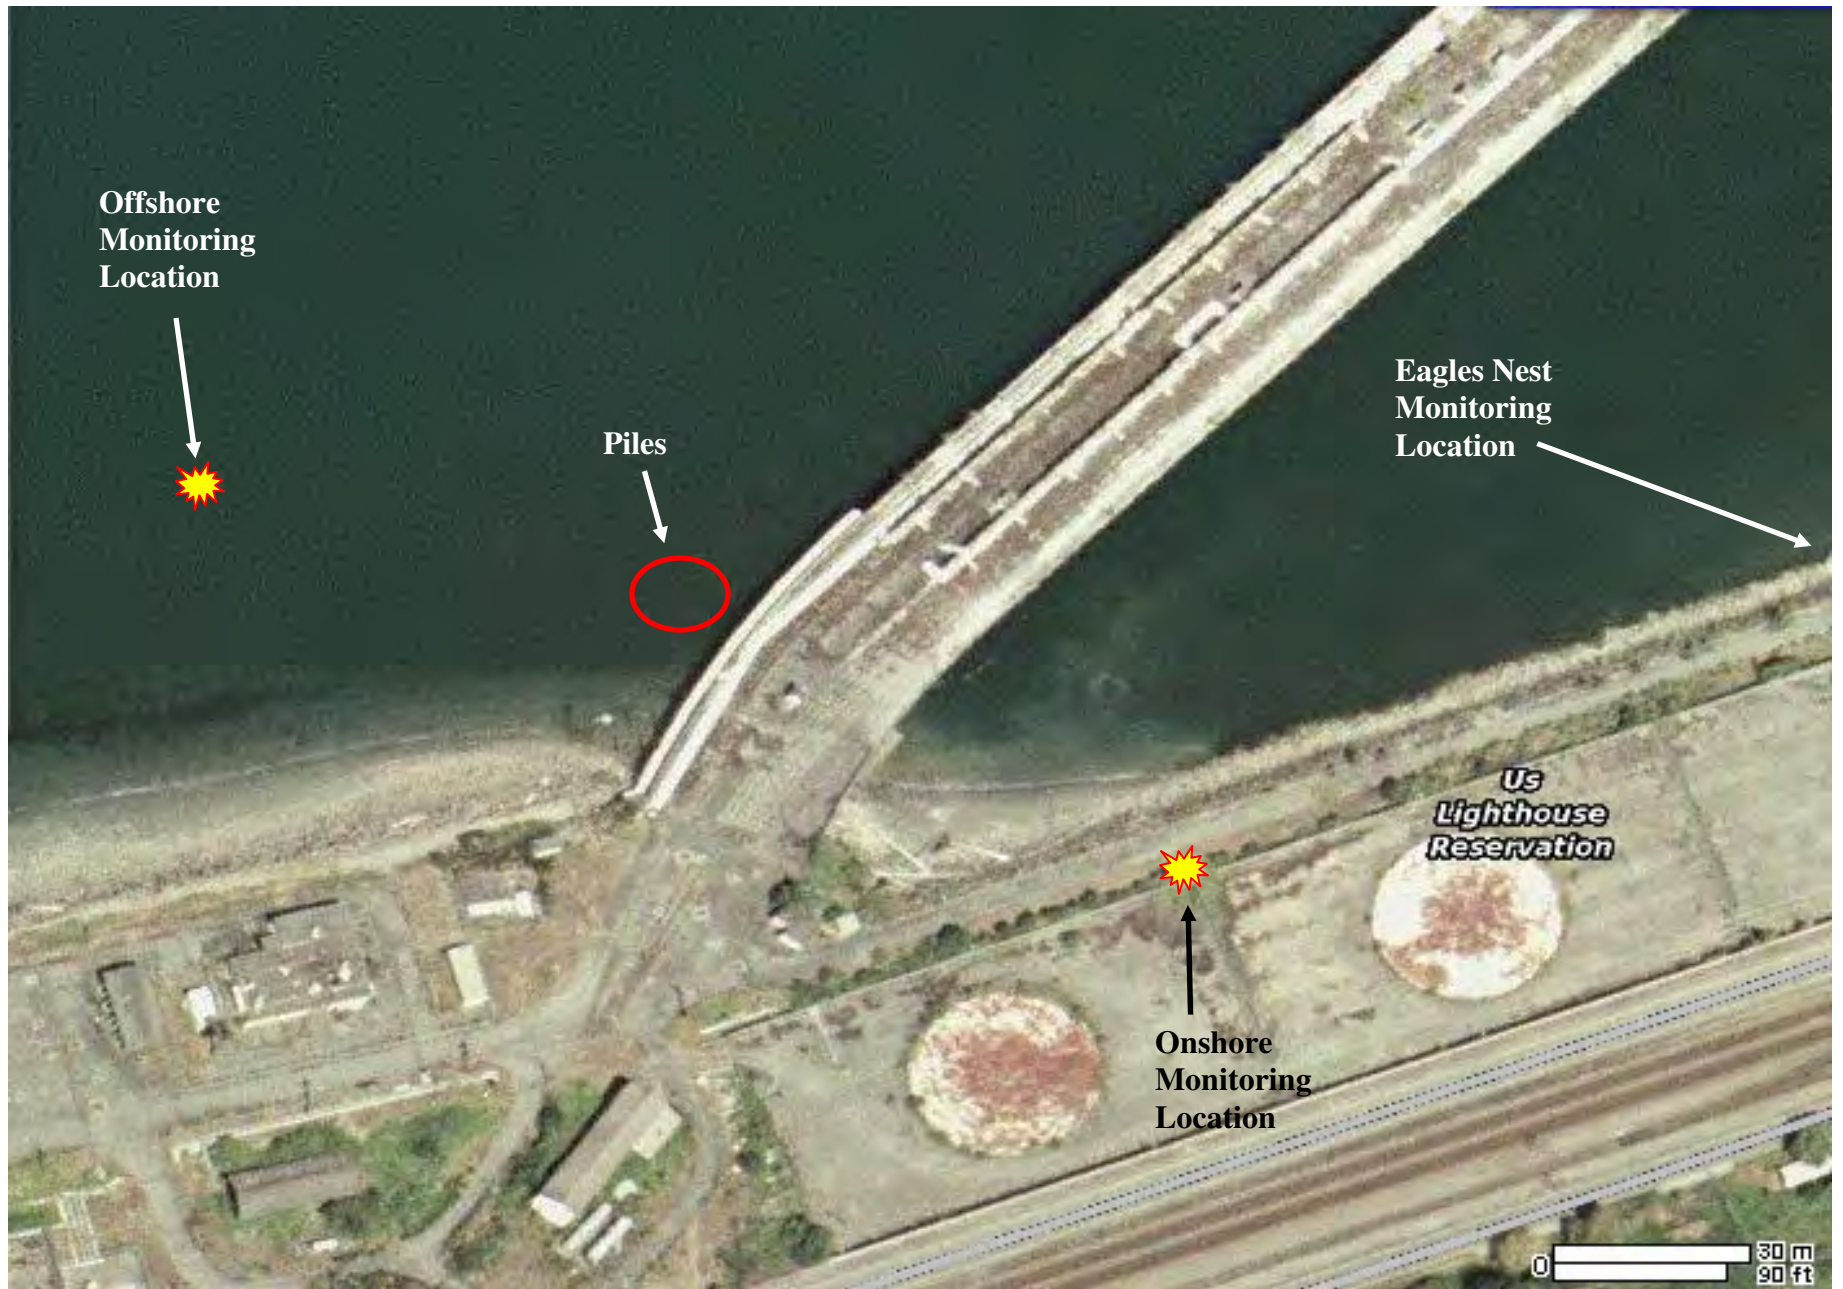
Figure 22: Airborne monitoring Locations.

- In a boat 300 feet from the pile being driven
- Onshore 300 feet from the pile being driven
- Onshore approximately 2,300 feet from the pile being driven beneath the nearest eagles nest.

Airborne noise measurements were made at three separate locations (Figure 22). Unfortunately due to issues with the noise meter, noise data was not collected at all locations for all piles. Data was collected from:

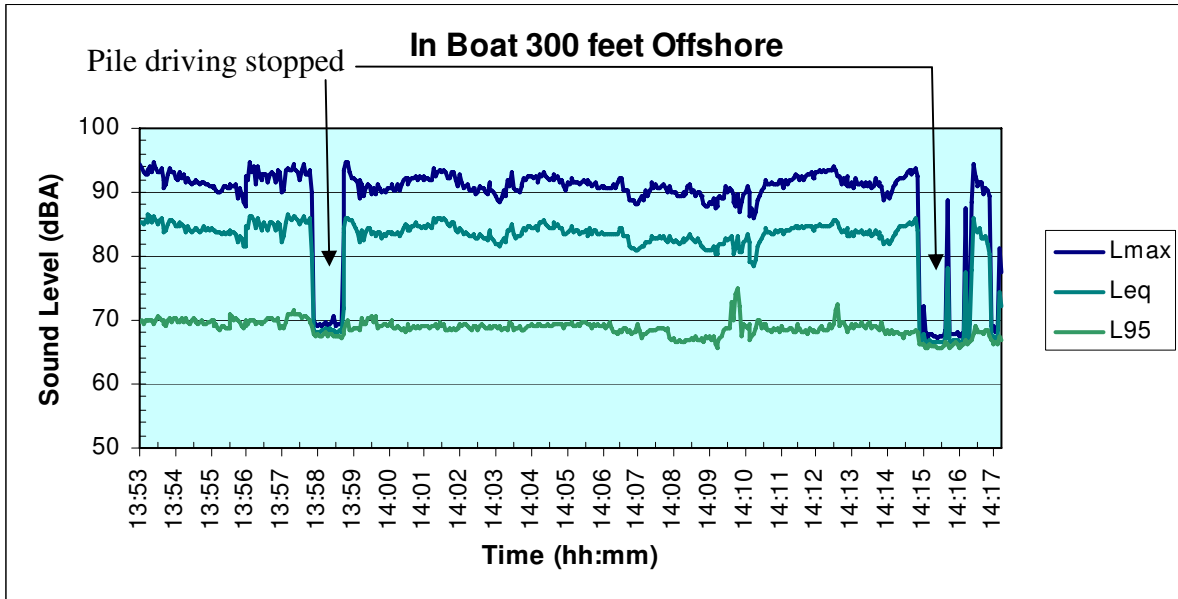
Figure 23: Typical plot of L_{max} , L_{95} , and L_{eq} for all pile strikes measured at the offshore site in a small boat for pile T4.

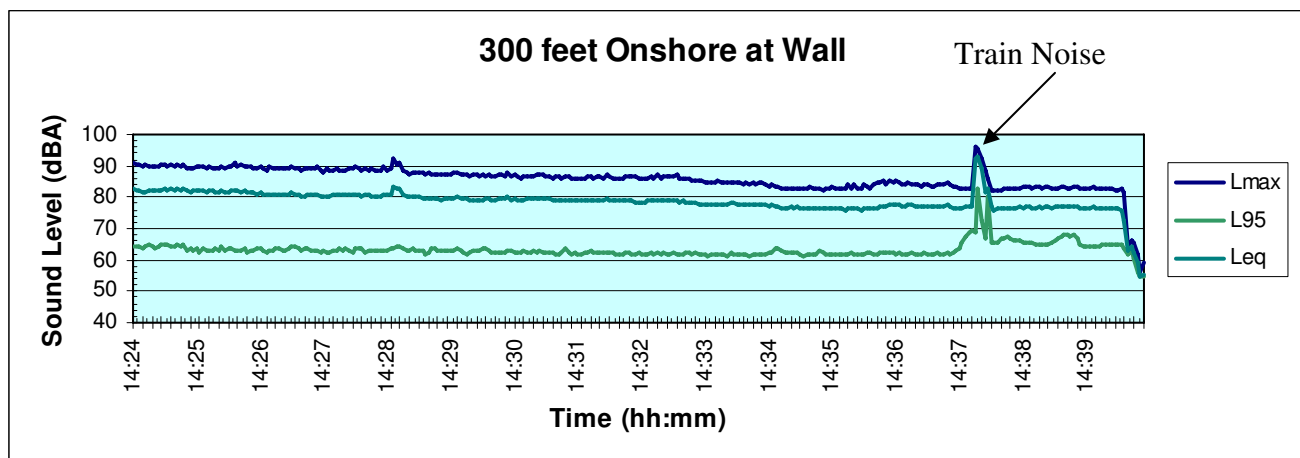
Figure 24: Typical plot of L_{max}, L₉₅, and L_{eq} for all pile strikes measured at the wall for pile T4.

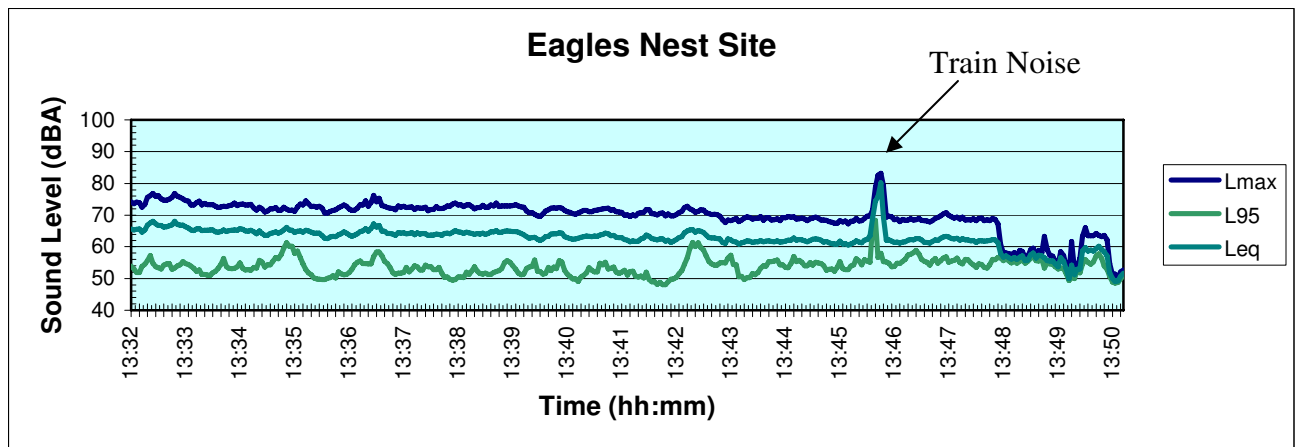
Figure 25: Typical plot of L_{max} , L_{95} , and L_{eq} for all pile strikes measured at the eagles nest site for pile T4.

Table 9 indicates the airborne L_{max} values for each pile monitored with a microphone mounted on a 25 foot pole held under the existing eagle's nest approximately 2,300 feet from the pile being driven. In this location, eagles were observed visiting, performing repairs and perching on the nest during pile driving. Large commercial airplanes, small private planes, and helicopters were also observed flying directly over the eagles nest at low altitude prior to landing at Paine

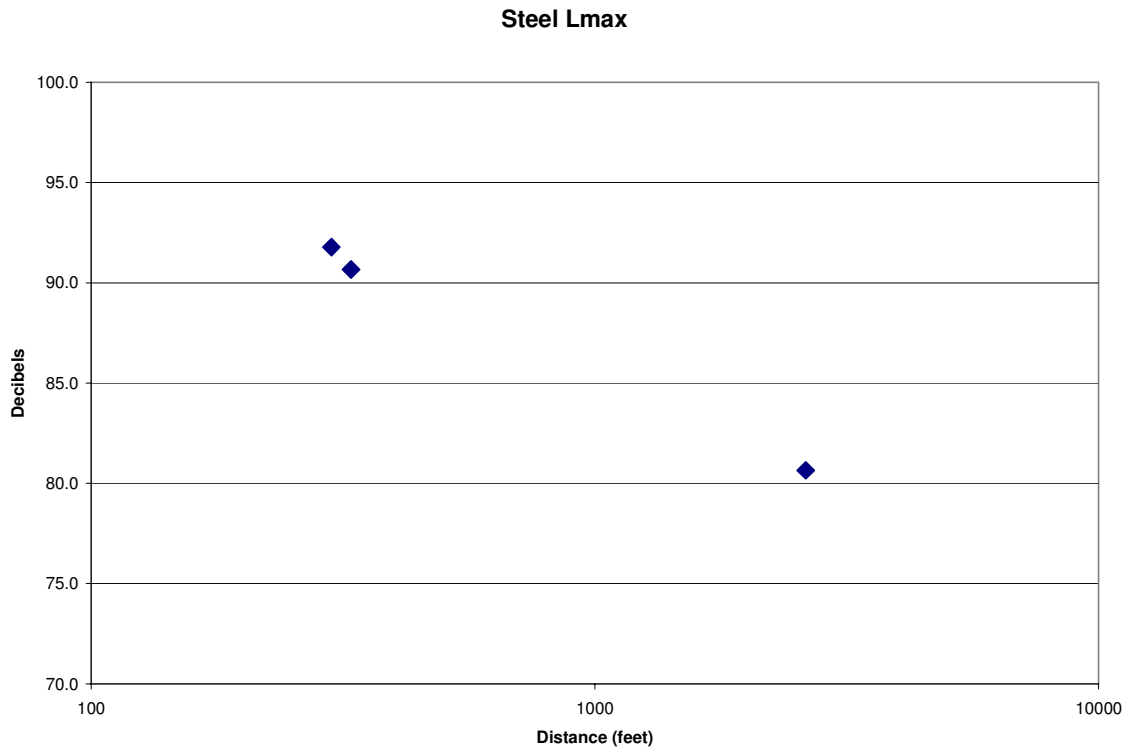
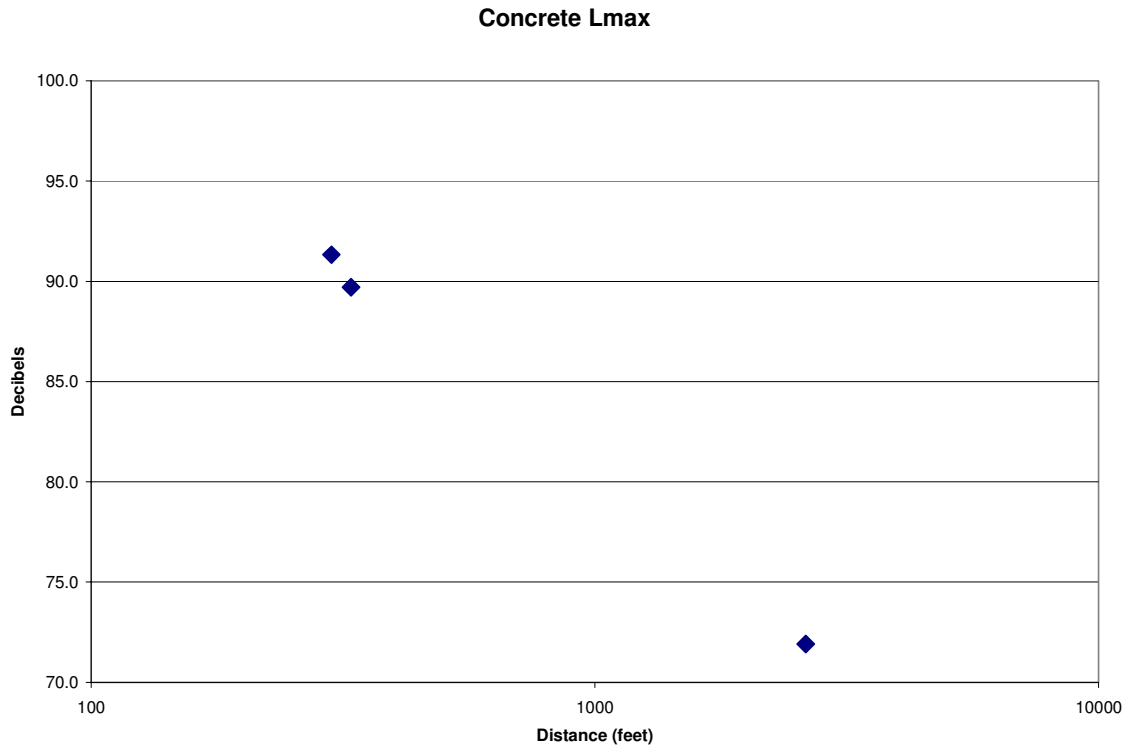
Figure 26 indicates the average L_{max} sound levels of pile strikes through air over distance. The data collected at the 20 meter range was not in a format that was comparable to the results below,

therefore, the 20 meter data were not able to be used in the plots below. Because the plots below have only two points a regression line is not appropriate for the data.

Figure 26: Plot of airborne average Lmax sound levels over distance for pile strikes at Mukilteo, Washington.

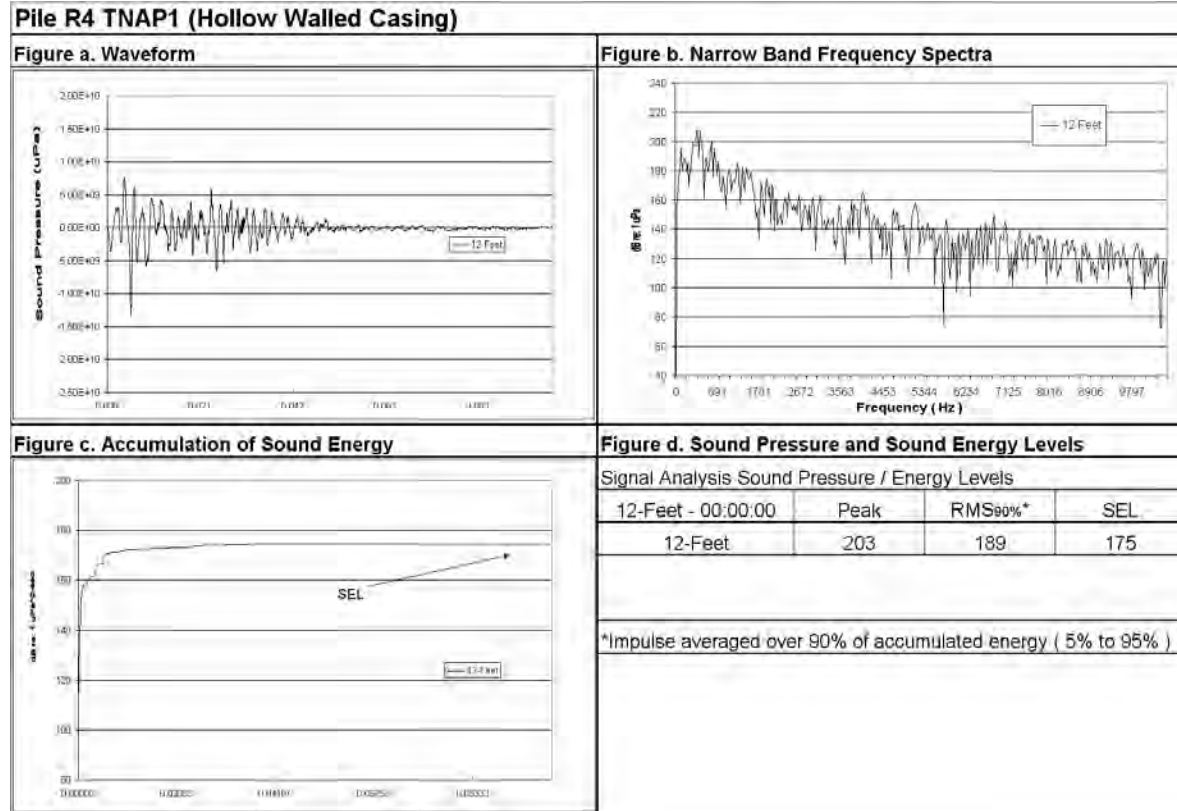
Figure 28: Waveform Analysis of Pile R4 Sound Pressure Levels with Temporary Noise Attenuation Pile 1 (TNAP1), Midwater.

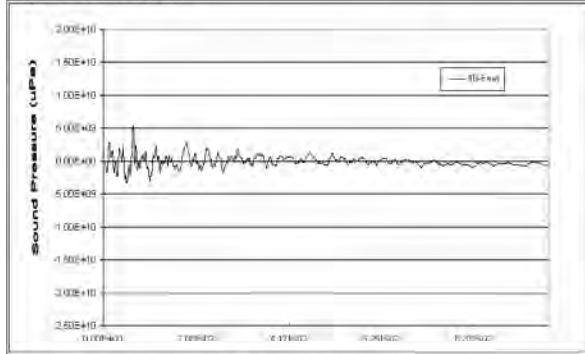
Figure a. Waveform

Pile R4 TNAP1 (Hollow Walled Casing-Retest)

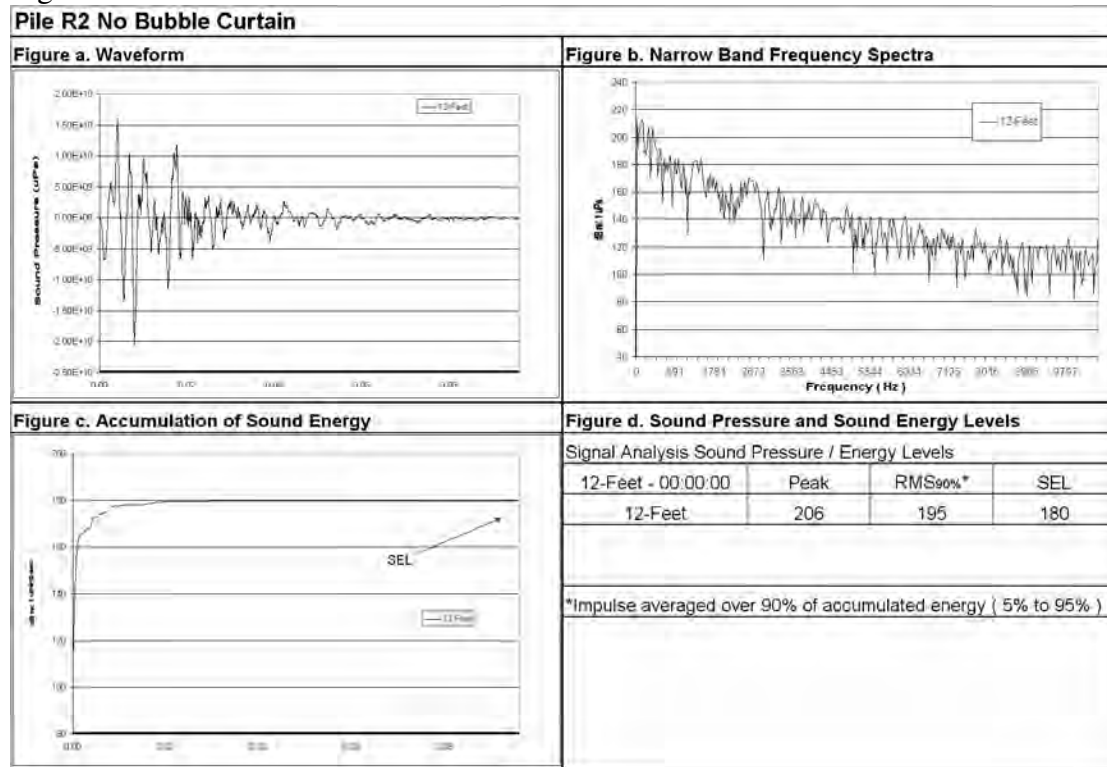
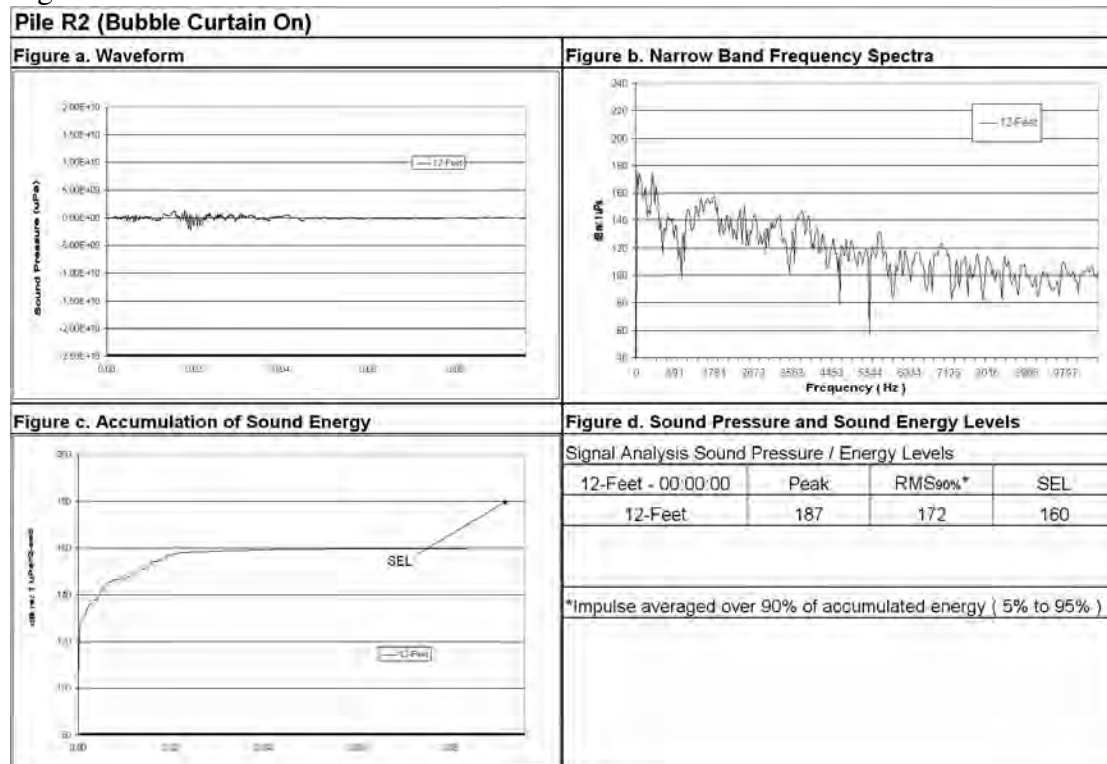
Figure 30: Waveform Analysis of Pile R2 Sound Pressure Levels with Bubble Curtain On (b) and Off (a), Midwater.

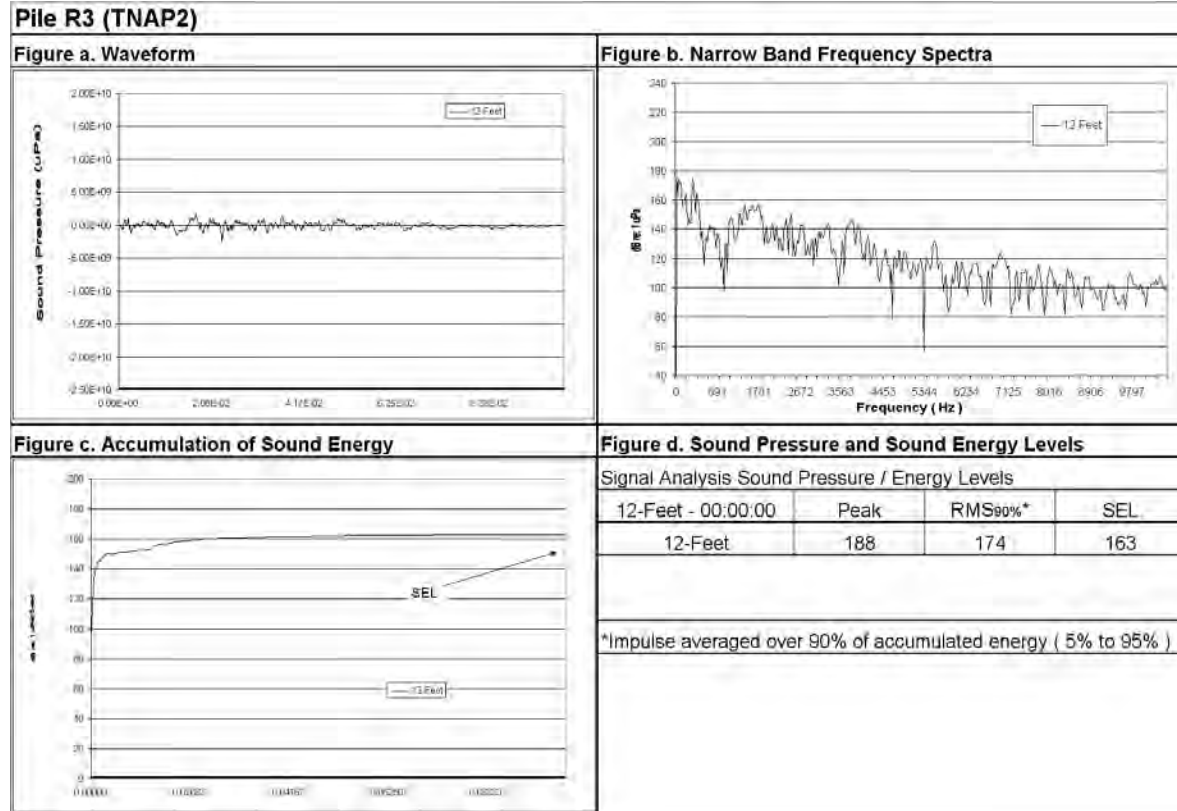
Figure 31: Waveform Analysis of Pile R3 Sound Pressure Levels with Temporary Noise Attenuation Pile 2 (TNAP2), Midwater.

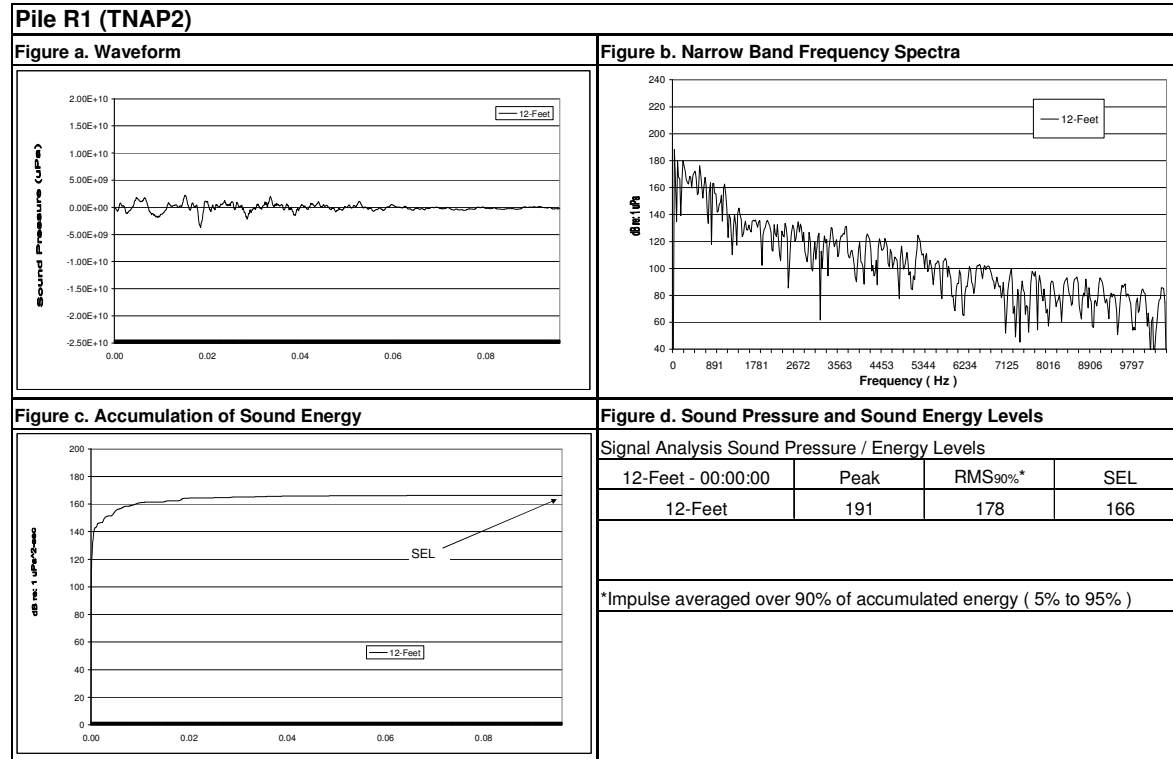
Figure 32: Waveform Analysis of Pile R1 Sound Pressure Levels with TNAP2, Midwater.

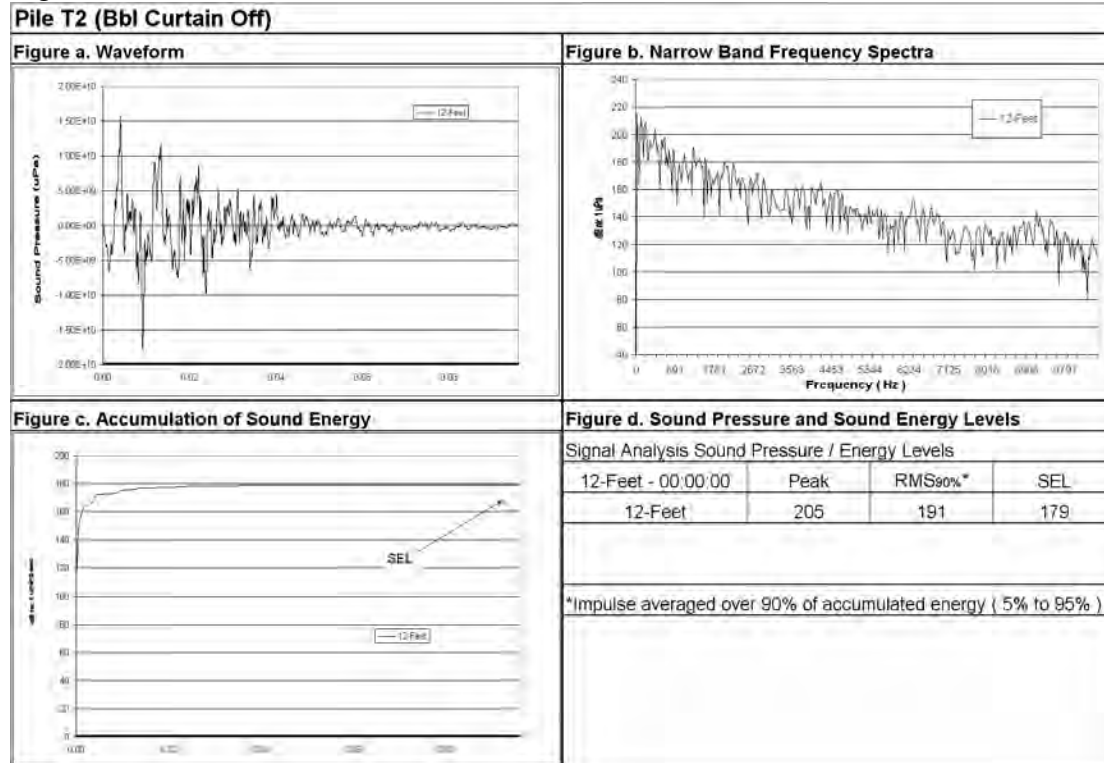
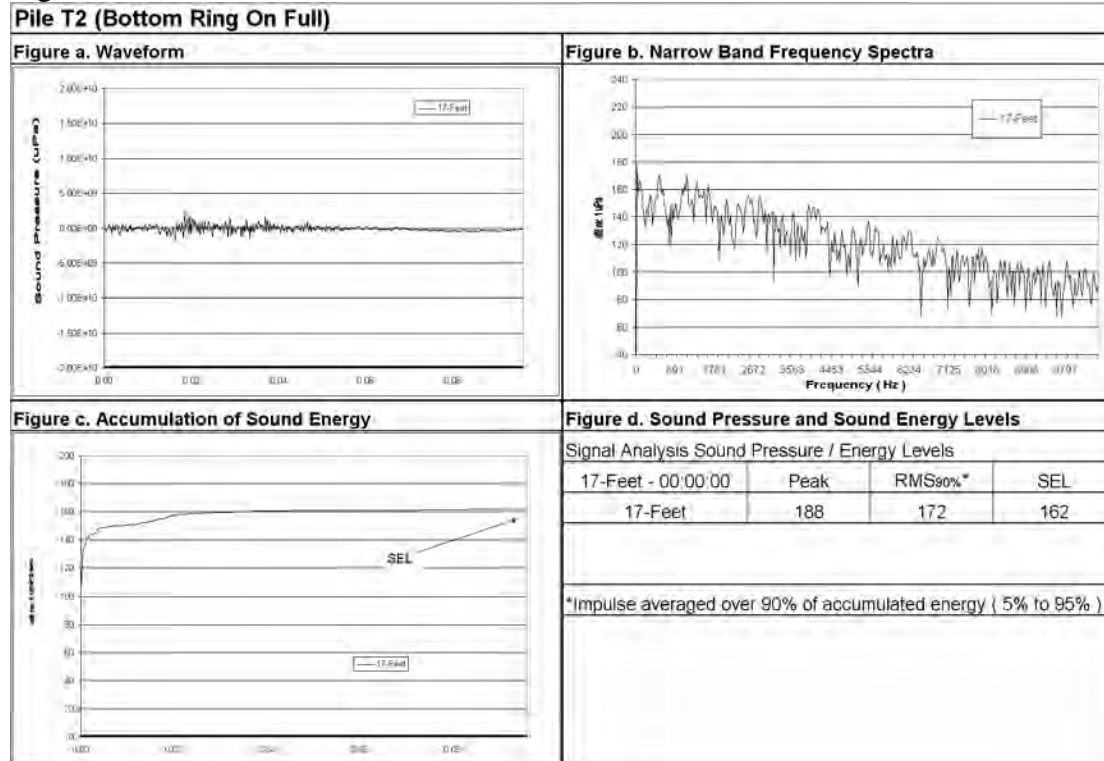
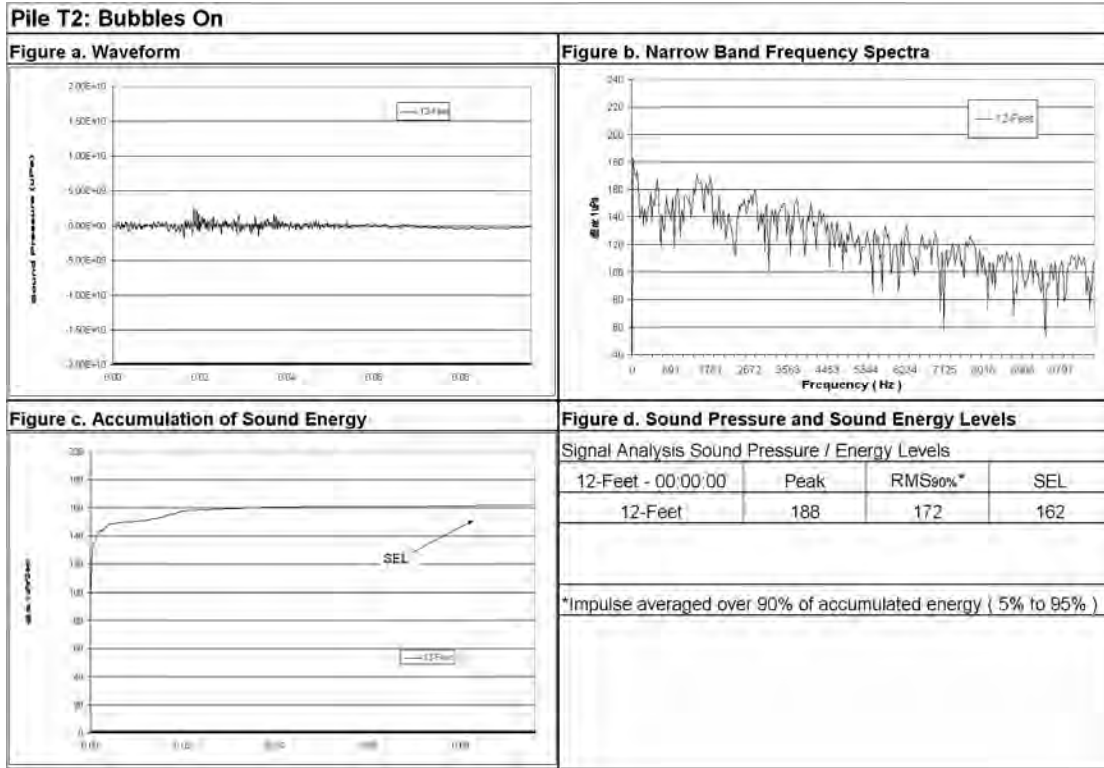
Figure 33: Waveform Analysis of Pile T2 Sound Pressure Levels with Bubble Curtain Off (a), Bottom Ring On Only (b), and Both Rings On (c), Midwater.

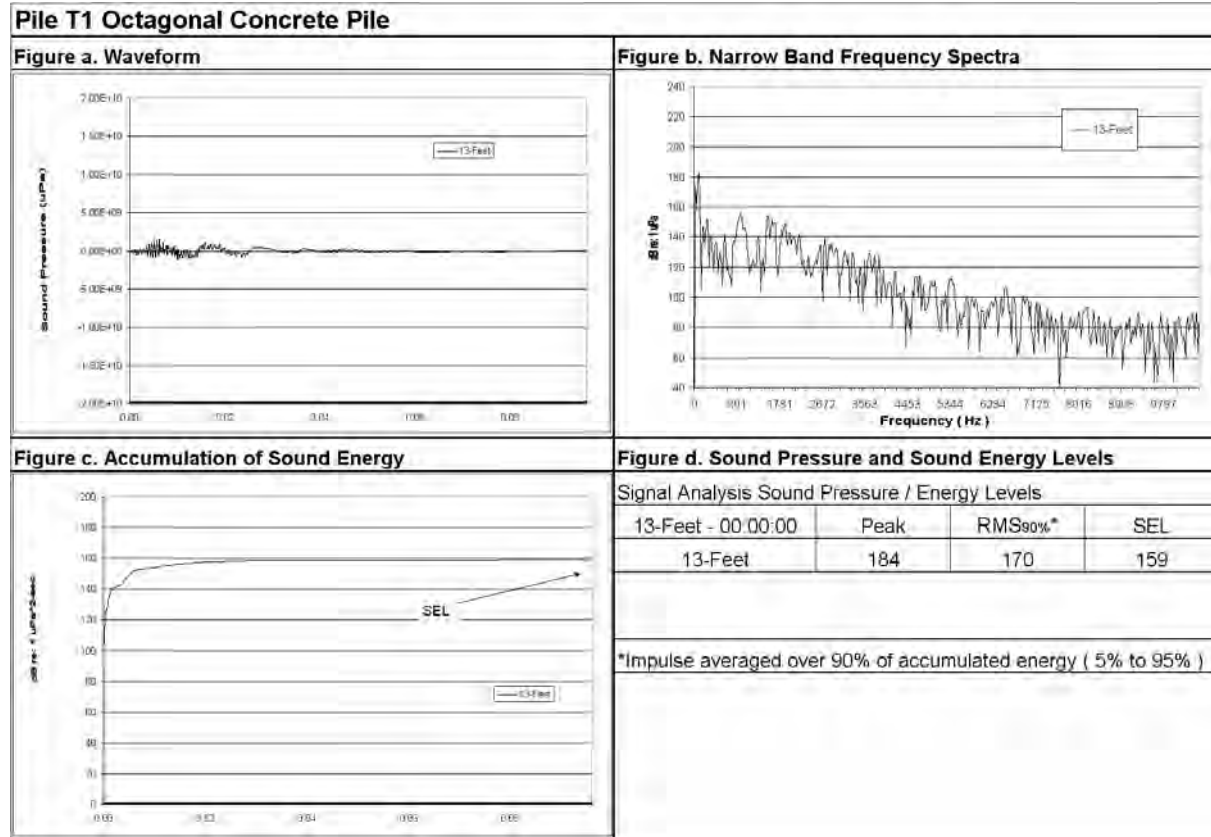
Figure 34: Waveform Analysis of Pile T1 Sound Pressure Levels of Octagonal Concrete Pile with 12-inch Wood Cap, Midwater.

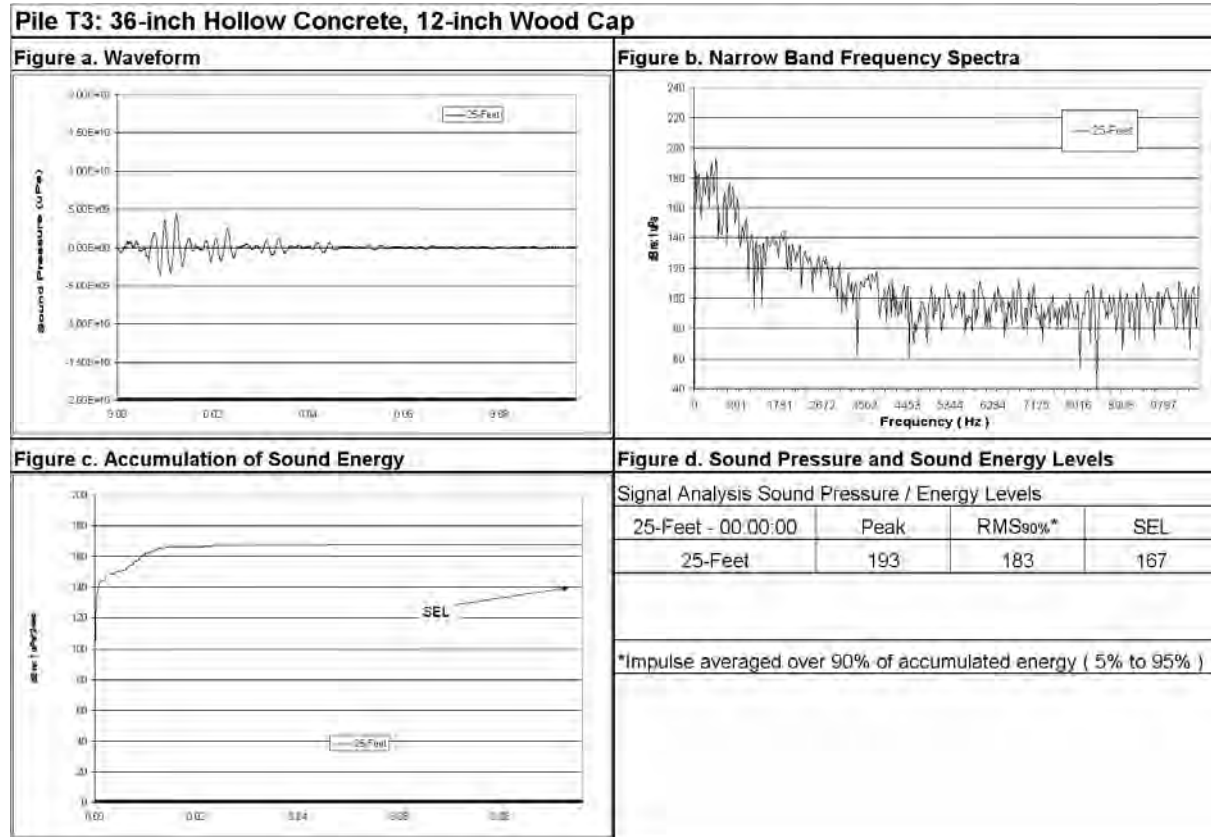
Figure 35: Waveform Analysis of Pile Number T3 Sound Pressure Levels of Hollow Concrete Pile with 12-inch Wood Cap, Midwater.

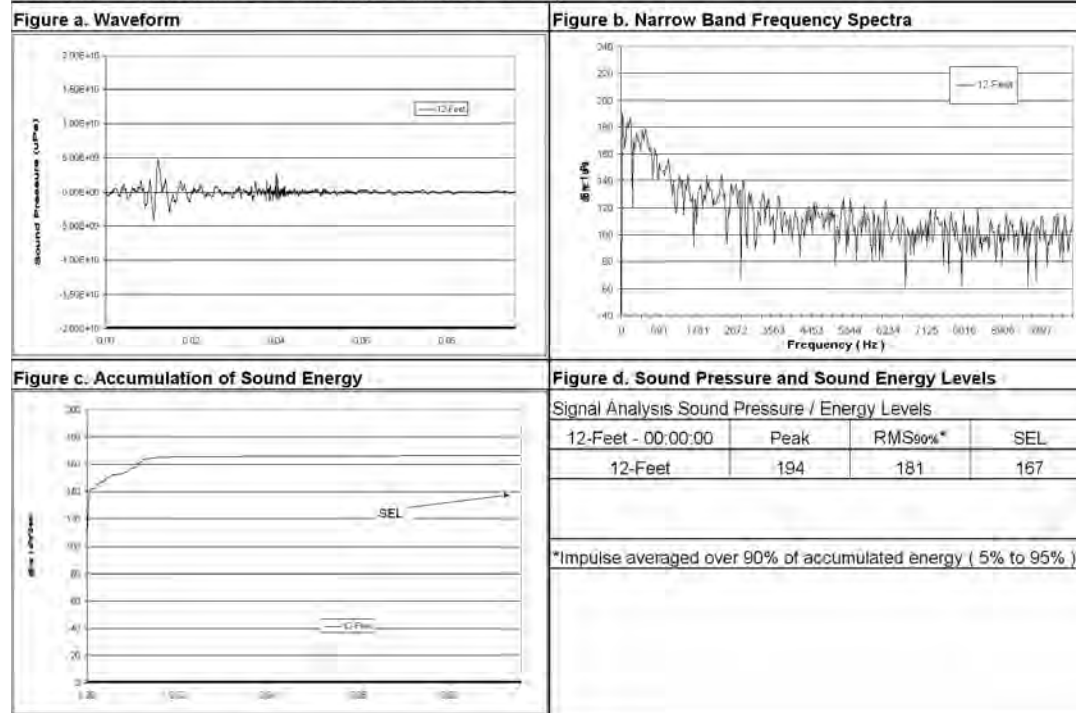
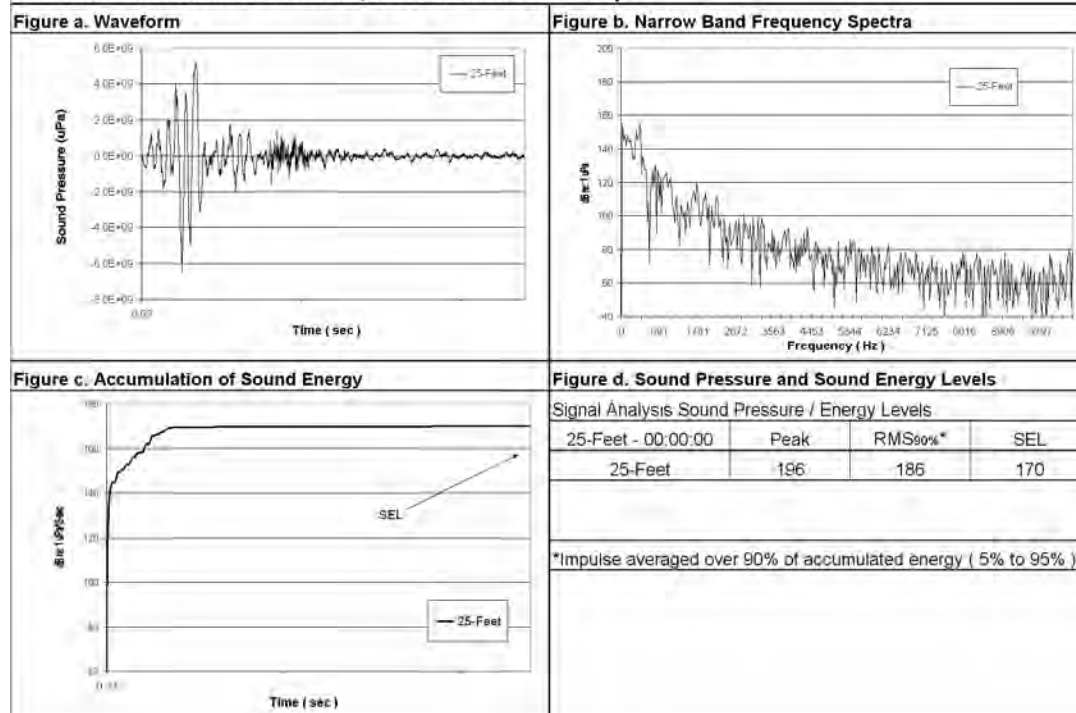
Pile T4: 36-inch Hollow Concrete, 12-inch Wood Cap

Pile T4: 36-inch Hollow Concrete, NEW 12-inch Wood Cap

Figure 36: Waveform Analysis of Pile Number T4 Sound Pressure Levels of Hollow Concrete Pile with 12-inch Wood Cap, Midwater.
